Access Compliance Report
Public Rights-of-Way
(Curb Ramps)

Main Street: CROWN_VALLEY_PKWY | **Cross Street:** ANTONIO_PKWY | **Location:** NW

ADA ID: RPRK211101113116 | **Ramp Type:** Type 1 - Perpendicular | **Initial Pass/Fail:** Fail | **Overall Compliance:** No | **Severity Score:** 15

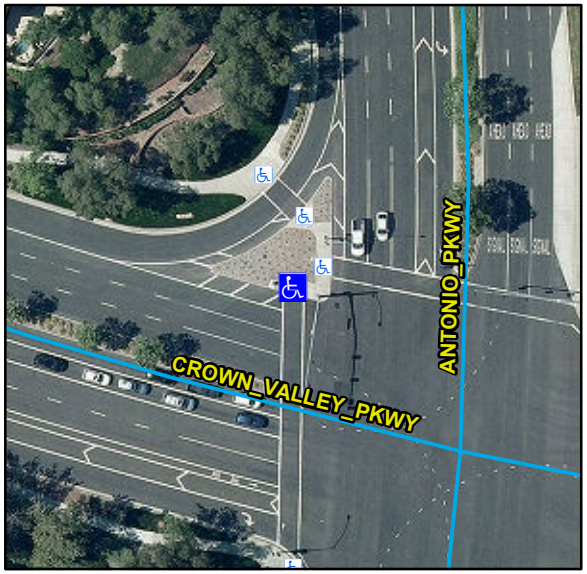
R204.3, R304.2.2, STD 1115

Remove & Replace Entire Ramp.
