Access Compliance Report
Public Rights-of-Way
(Curb Ramps)

Main Street: DE_LEON_LN | **Cross Street: PERCHERON_DR** | **Location: N**

ADA ID: RPRK211112144601 | **Ramp Type: Type 4 - Parallel** | **Initial Pass/Fail: Pass** | **Overall Compliance: No** | **Severity Score: 25**

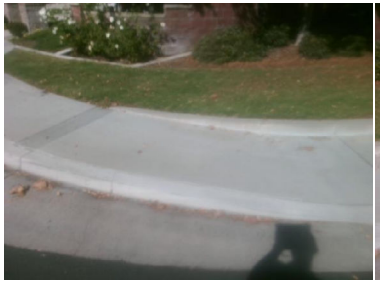
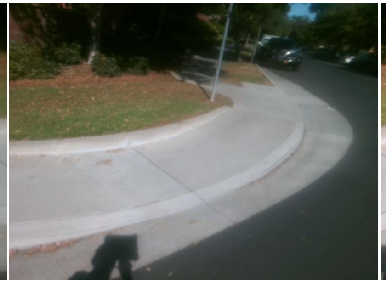
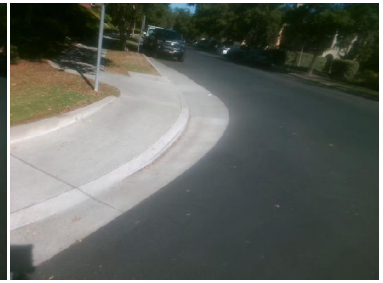
Compliance	Description	Data	Compliance	Description	Data
N/A	Ramp Length LT (in)	**130**	**N/A**	Ramp Length RT (in)	**121**
Yes	Ramp Width LT (in)	**50**	**Yes**	Ramp Width RT (in)	**50**
Yes	Ramp Run Slope LT (%)	**3.5**	**Yes**	Ramp Run Slope RT (%)	**7.6**
Yes	Ramp Cross Slope LT (%)	**0.5**	**Yes**	Ramp Cross Slope RT (%)	**1.1**
N/A	Landing Present	**No**	**No**	DWS Provided	**No**
N/A	Landing Length (in)	**N/A**	**N/A**	DWS Contrast	**N/A**
No	Landing Width (in)	**N/A**	**N/A**	DWS Length (in)	**N/A**
No	Landing Run Slope (%)	**N/A**	**N/A**	DWS Full Width	**N/A**
No	Landing Cross Slope (%)	**N/A**		DWS Offset Type	**N/A**
N/A	Landing Movement Obstructed?	**No**	**N/A**	DWS Offset Left (in)	**N/A**
	Landing Movement Type	**Curb**	**N/A**	DWS Offset Right (in)	**N/A**
N/A	Landing Shared	**N/A**			
N/A	Clear Space	**Yes**			
N/A	Clear Space To Crosswalk (in)	**48**			
N/A	Marked Crosswalk 1	**No**	**N/A**	Marked Crosswalk 2	**No**

Crossing 1 Direction	**SW**		Crossing 2 Direction	**SE**
	Marked Crosswalk 1 Width (in)	**N/A**		Marked Crosswalk 2 Width (in)	**N/A**
N/A	Ramp Inside Crosswalk 1	**N/A**	**N/A**	Ramp Inside Crosswalk 2	**N/A**
	Crossing 1 Slope (%)	**3.3**		Crossing 2 Slope (%)	**2.5**
	Crossing 1 Cross Slope (%)	**0.1**		Crossing 2 Cross Slope (%)	**4**
Yes	Gutter Ponding	**No**	**No**	Curb Slope	**11.5**
Yes	Gutter Lip Height (in)	**0**		Road Run Slope (%)	**3**
No	Gutter Run Slope (%)	**6.6**		Road Cross Slope (%)	**2.8**
Yes	Gutter Cross Slope (%)	**0.6**	**No**	Perpendicular Joint Present	**No**
Yes	Overall Surface Condition	**Acceptable**			
	Cross Gutter Present?	**No**		Spandrel Present?	**No**
	Replace Cross Gutter?	**N/A**		Replace Spandrel?	**N/A**

Remove & Replace Curb Ramp With Two New Directional Ramps or Equivalent. Remove & Replace Gutter.
