Access Compliance Report
Public Rights-of-Way
(Curb Ramps)

Main Street: REATA_RD | **Cross Street: N/A** | **Location: SW**

ADA ID: RPRK211118135027 | **Ramp Type:Type 1 - Perpendicular** | **Initial Pass/Fail: Fail** | **Overall Compliance: No** | **Severity Score: 15**

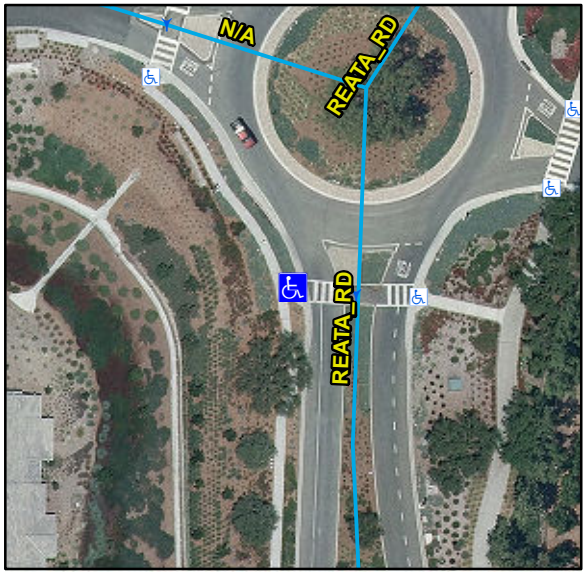
Compliance	Description	Data	Compliance	Description	Data
N/A	Ramp Length (in)	**64**	**N/A**	Flare Type LT	
Yes	Ramp Width (in)	**60**			**N/A**
No	Ramp Run Slope (%)	**9.4**	**N/A**	Flare Slope LT (%)	**N/A**
Yes	Ramp Cross Slope (%)	**4**	**N/A**	Flare Traversable LT	**N/A**
N/A	Landing Present	**N/A**	**N/A**	Flare Type RT	
N/A	Landing Length (in)	**N/A**			**N/A**
N/A	Landing Width (in)	**N/A**	**N/A**	Flare Slope RT (%)	**N/A**
N/A	Landing Run Slope (%)	**N/A**	**N/A**	Flare Traversable RT	**N/A**
N/A	Landing Cross Slope (%)	**N/A**	**N/A**	DWS Provided	**N/A**
N/A	Landing Movement Obstructed?	**N/A**	**N/A**	DWS Contrast	**N/A**
	Landing Movement Type	**N/A**	**N/A**	DWS Length (in)	**N/A**
N/A	Landing Shared	**N/A**	**N/A**	DWS Full Width	**N/A**
N/A	Clear Space	**N/A**	**N/A**	DWS Offset Left (in)	**N/A**
N/A	Clear Space To Crosswalk (in)	**N/A**	**N/A**	DWS Offset Right (in)	**N/A**
N/A	Marked Crosswalk 1	**Yes**	**N/A**	Marked Crosswalk 2	**N/A**

Remove & Replace Entire Ramp.
