Access Compliance Report
Public Rights-of-Way
(Curb Ramps)

Main Street: LIGADO_ST | **Cross Street:** FORMERO_ST | **Location:** NE

ADA ID: RPRK211119121125 | **Ramp Type:** Type 4 - Parallel | **Initial Pass/Fail:** Fail | **Overall Compliance:** No | **Severity Score:** 2

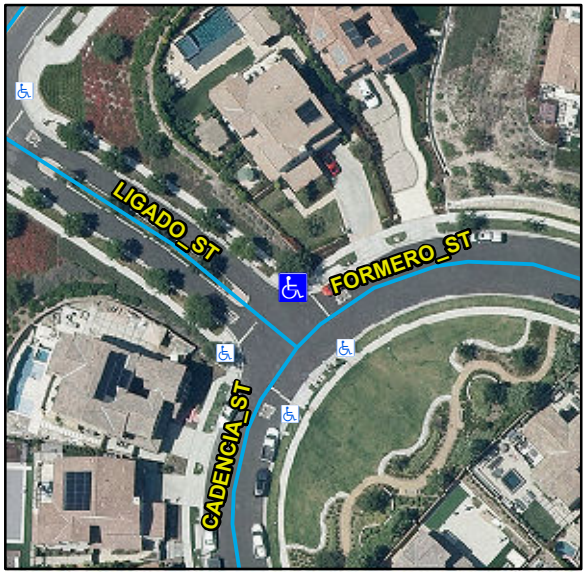
R304.5.3, STD 1115

Remove & Replace Curb Ramp With Two New Directional Ramps or Equivalent.
