Access Compliance Report
Public Rights-of-Way
(Curb Ramps)

Main Street: TIERNO_RD | **Cross Street: ANDAZA_ST** | **Location: S**

ADA ID: RPRK211129125208 | **Ramp Type:Type 1 - Perpendicular** | **Initial Pass/Fail: Pass** | **Overall Compliance: No** | **Severity Score: 2**

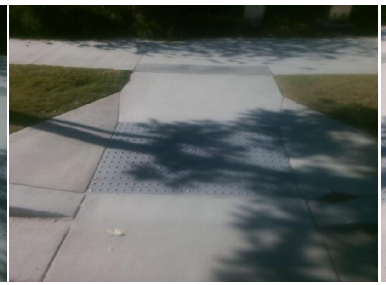
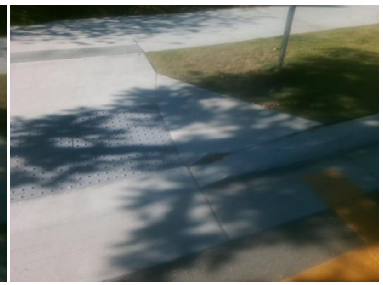
R304.2.2, STD 1115

Remove & Replace Curb Slope.
