Access Compliance Report
Public Rights-of-Way
(Curb Ramps)

Main Street: VENTADA_ST **Cross Street:** VENTADA_ST **Location:** N

ADA ID: RPRK211129134423 **Ramp Type:** No Ramp **Initial Pass/Fail:** N/A **Overall Compliance:** No **Severity Score:** 100

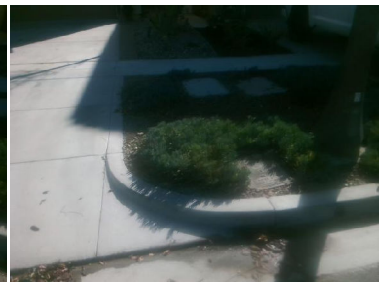
N/A

Provide Curb Ramp

STD 1115

Total Cost: **$ 3080**
