Access Compliance Report
Public Rights-of-Way
(Curb Ramps)

Main Street: AIROSO_ST | **Cross Street: ESENCIA_DR** | **Location: S**

ADA ID: RPRK211201132042 | **Ramp Type: Type 4 - Parallel** | **Initial Pass/Fail: Pass** | **Overall Compliance: No** | **Severity Score: 6**

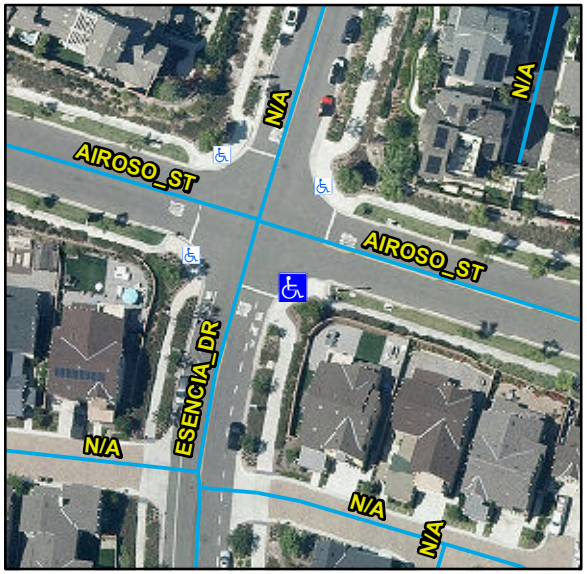
R304.5.3, R304.5.4, STD 1115

Remove & Replace Landing. Remove & Replace Gutter.
