Access Compliance Report
Public Rights-of-Way
(Curb Ramps)

Main Street: ORANGEWOOD_AVE | **Cross Street:** WALLINGSFORD_RD | **Location:** S

ADA ID: RPRK211215142609 | **Ramp Type:** Type 4 - Parallel | **Initial Pass/Fail:** Fail | **Overall Compliance:** No | **Severity Score:** 45

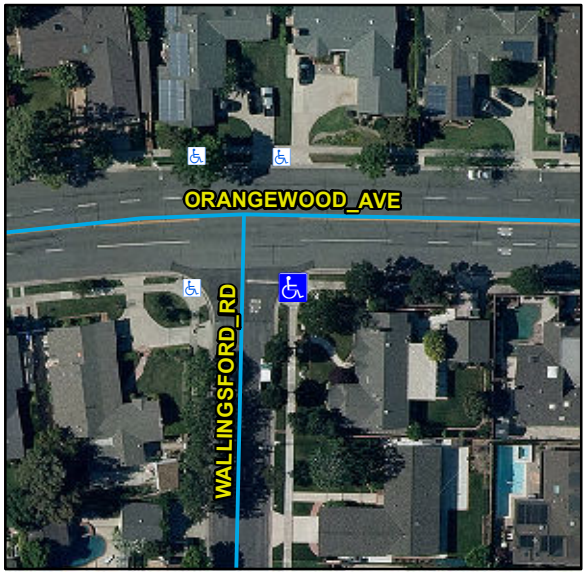
R204.3, R304.3.2, R304.5.3, STD 1115

Compliance	Description	Data	Compliance	Description	Data
N/A	Ramp Length LT (in)	109	N/A	Ramp Length RT (in)	111
Yes	Ramp Width LT (in)	112	Yes	Ramp Width RT (in)	112
No	Ramp Run Slope LT (%)	9.1	Yes	Ramp Run Slope RT (%)	5.4
No	Ramp Cross Slope LT (%)	7.3	No	Ramp Cross Slope RT (%)	2.5
N/A	Landing Present	N/A	N/A	DWS Provided	N/A
N/A	Landing Length (in)	N/A	N/A	DWS Contrast	N/A
N/A	Landing Width (in)	N/A	N/A	DWS Length (in)	N/A
N/A	Landing Run Slope (%)	N/A	N/A	DWS Full Width	N/A
N/A	Landing Cross Slope (%)	N/A		DWS Offset Type	N/A
N/A	Landing Movement Obstructed?	N/A	N/A	DWS Offset Left (in)	N/A
	Landing Movement Type	N/A	N/A	DWS Offset Right (in)	N/A
N/A	Landing Shared	N/A			
N/A	Clear Space	Yes			
N/A	Clear Space To Crosswalk (in)	N/A			
N/A	Marked Crosswalk 1	No	N/A	Marked Crosswalk 2	No
	Crossing 1 Direction	N		Crossing 2 Direction	W
	Marked Crosswalk 1 Width (in)	N/A		Marked Crosswalk 2 Width (in)	N/A

Remove & Replace Curb Ramp With Two New Directional Ramps or Equivalent.
