Access Compliance Report
Public Rights-of-Way
(Curb Ramps)

Main Street: IRVINE_BLVD | **Cross Street: TUSTIN_RANCH_RD** | **Location: SW**

ADA ID: RPRK220103131115 | **Ramp Type:Type 1 - Perpendicular Diagonal Initial Pass/Fail: Pass** | **Overall Compliance: No** | **Severity Score: 0**

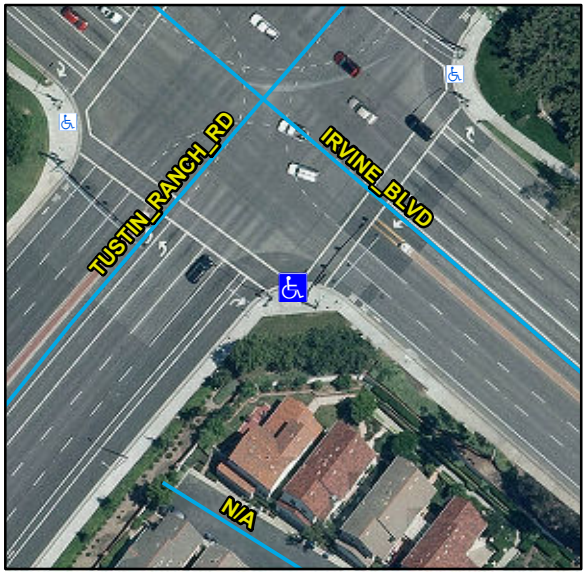
Compliance	Description	Data	Compliance	Description	Data
N/A	Ramp Length (in)	**118**	**N/A**	Flare Type LT	
Yes	Ramp Width (in)	**48**			**Sloped**
Yes	Ramp Run Slope (%)	**7.3**	**Yes**	Flare Slope LT (%)	**8.8**
Yes	Ramp Cross Slope (%)	**1.1**	**N/A**	Flare Traversable LT	**Yes**
N/A	Landing Present	**Yes**	**N/A**	Flare Type RT	
N/A	Landing Length (in)	**48**			**Sloped**
Yes	Landing Width (in)	**48**	**N/A**	Flare Slope RT (%)	**5**
No	Landing Run Slope (%)	**2.1**	**N/A**	Flare Traversable RT	**No**
Yes	Landing Cross Slope (%)	**1.4**	**Yes**	DWS Provided	**Yes**
N/A	Landing Movement Obstructed?	**No**	**Yes**	DWS Contrast	**Yes**
	Landing Movement Type	**N/A**	**Yes**	DWS Length (in)	**36**
N/A	Landing Shared	**No**	**Yes**	DWS Full Width	**Yes**
Yes	Clear Space	**Yes**	**Yes**	DWS Offset Left (in)	**0**
Yes	Clear Space To Crosswalk (in)	**48**	**Yes**	DWS Offset Right (in)	**N/A**
N/A	Marked Crosswalk 1	**Yes**	**N/A**	Marked Crosswalk 2	**Yes**

Remove & Replace Landing. Remove & Replace Gutter.

R304.2.2-Perp, R304.3.2-Para, R304.5.3, STD 1115
