Access Compliance Report
Public Rights-of-Way
(Curb Ramps)

Main Street: HOLT_AVE | **Cross Street: WESTON_PL** | **Location: SW**

ADA ID: RPRK220124115203 | **Ramp Type: Type 4 - Parallel** | **Initial Pass/Fail: Fail** | **Overall Compliance: No** | **Severity Score: 15**

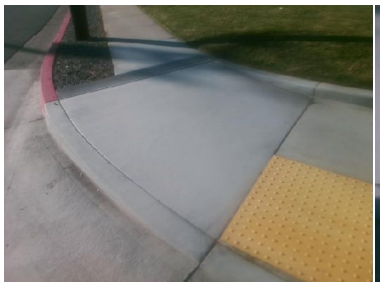
Compliance	Description	Data	Compliance	Description	Data
N/A	Ramp Length LT (in)	**100**	**N/A**	Ramp Length RT (in)	**102**
Yes	Ramp Width LT (in)	**88**	**Yes**	Ramp Width RT (in)	**88**
Yes	Ramp Run Slope LT (%)	**3.8**	**No**	Ramp Run Slope RT (%)	**9.1**
Yes	Ramp Cross Slope LT (%)	**1.3**	**Yes**	Ramp Cross Slope RT (%)	**1.3**
N/A	Landing Present	**N/A**	**N/A**	DWS Provided	**N/A**
N/A	Landing Length (in)	**N/A**	**N/A**	DWS Contrast	**N/A**
N/A	Landing Width (in)	**N/A**	**N/A**	DWS Length (in)	**N/A**
N/A	Landing Run Slope (%)	**N/A**	**N/A**	DWS Full Width	**N/A**
N/A	Landing Cross Slope (%)	**N/A**		DWS Offset Type	**N/A**
N/A	Landing Movement Obstructed?	**N/A**	**N/A**	DWS Offset Left (in)	**N/A**
	Landing Movement Type	**N/A**	**N/A**	DWS Offset Right (in)	**N/A**
N/A	Landing Shared	**N/A**			
N/A	Clear Space	**Yes**			
N/A	Clear Space To Crosswalk (in)	**N/A**			
N/A	Marked Crosswalk 1	**No**	**N/A**	Marked Crosswalk 2	**No**

Remove & Replace Curb Ramp With Two New Directional Ramps or Equivalent.
