Access Compliance Report
Public Rights-of-Way
(Curb Ramps)

Main Street: JUDY_ANNE_LN **Cross Street:** CHADBOURNE_LN **Location:** NE

ADA ID: RPRK220125134437 **Ramp Type:** Type 4 - Parallel **Initial Pass/Fail:** Fail **Overall Compliance:** No **Severity Score:** 2

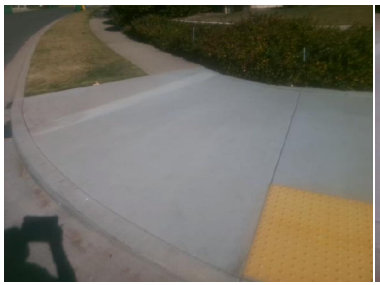
Compliance	Description	Data	Compliance	Description	Data
N/A	Ramp Length LT (in)	110	N/A	Ramp Length RT (in)	89
Yes	Ramp Width LT (in)	134	Yes	Ramp Width RT (in)	134
Yes	Ramp Run Slope LT (%)	2.8	Yes	Ramp Run Slope RT (%)	5.1
No	Ramp Cross Slope LT (%)	4.2	No	Ramp Cross Slope RT (%)	4.4
N/A	Landing Present	N/A	N/A	DWS Provided	N/A
N/A	Landing Length (in)	N/A	N/A	DWS Contrast	N/A
N/A	Landing Width (in)	N/A	N/A	DWS Length (in)	N/A
N/A	Landing Run Slope (%)	N/A	N/A	DWS Full Width	N/A
N/A	Landing Cross Slope (%)	N/A		DWS Offset Type	N/A
N/A	Landing Movement Obstructed?	N/A	N/A	DWS Offset Left (in)	N/A
	Landing Movement Type	N/A	N/A	DWS Offset Right (in)	N/A
N/A	Landing Shared	N/A			
N/A	Clear Space	Yes			
N/A	Clear Space To Crosswalk (in)	N/A			
N/A	Marked Crosswalk 1	No	N/A	Marked Crosswalk 2	No
	Crossing 1 Direction	W		Crossing 2 Direction	S
	Marked Crosswalk 1 Width (in)	N/A		Marked Crosswalk 2 Width (in)	N/A

Remove & Replace Curb Ramp With Two New Directional Ramps or Equivalent.
