Access Compliance Report
Public Rights-of-Way
(Curb Ramps)

Main Street: ANGLIN_LN | **Cross Street: PROSPECT_AVE** | **Location: NW**

ADA ID: RPRK220127123506 | **Ramp Type: Type 4 - Parallel** | **Initial Pass/Fail: Fail** | **Overall Compliance: No** | **Severity Score: 2**

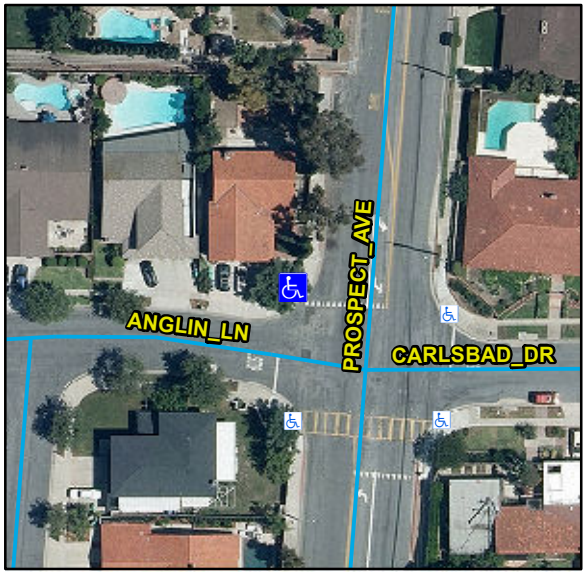
R204.3, R304.5.3, R302.7.2, STD 1115

Remove & Replace Curb Ramp With Two New Directional Ramps or Equivalent. Grind Gutter Lip.

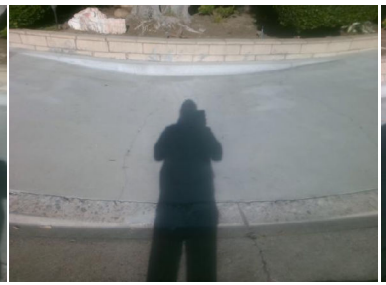
Compliance	Description	Data	Compliance	Description	Data
N/A	Ramp Length LT (in)	**111**	**N/A**	Ramp Length RT (in)	**114**
Yes	Ramp Width LT (in)	**95**	**Yes**	Ramp Width RT (in)	**95**
Yes	Ramp Run Slope LT (%)	**7.4**	**Yes**	Ramp Run Slope RT (%)	**7.4**
No	Ramp Cross Slope LT (%)	**3.2**	**No**	Ramp Cross Slope RT (%)	**2.3**
N/A	Landing Present	**N/A**	**N/A**	DWS Provided	**N/A**
N/A	Landing Length (in)	**N/A**	**N/A**	DWS Contrast	**N/A**
N/A	Landing Width (in)	**N/A**	**N/A**	DWS Length (in)	**N/A**
N/A	Landing Run Slope (%)	**N/A**	**N/A**	DWS Full Width	**N/A**
N/A	Landing Cross Slope (%)	**N/A**		DWS Offset Type	**N/A**
N/A	Landing Movement Obstructed?	**N/A**	**N/A**	DWS Offset Left (in)	**N/A**
	Landing Movement Type	**N/A**	**N/A**	DWS Offset Right (in)	**N/A**
N/A	Landing Shared	**N/A**			
N/A	Clear Space	**Yes**			
N/A	Clear Space To Crosswalk (in)	**N/A**			
N/A	Marked Crosswalk 1	**No**	**N/A**	Marked Crosswalk 2	**No**
