Access Compliance Report
Public Rights-of-Way
(Curb Ramps)

Main Street: ERVIN_LN | **Cross Street: GIMBERT_LN** | **Location: NW**

ADA ID: RPRK220127132406 | **Ramp Type:Type 1 - Perpendicular Diagonal** | **Initial Pass/Fail: Pass** | **Overall Compliance: No** | **Severity Score: 0**

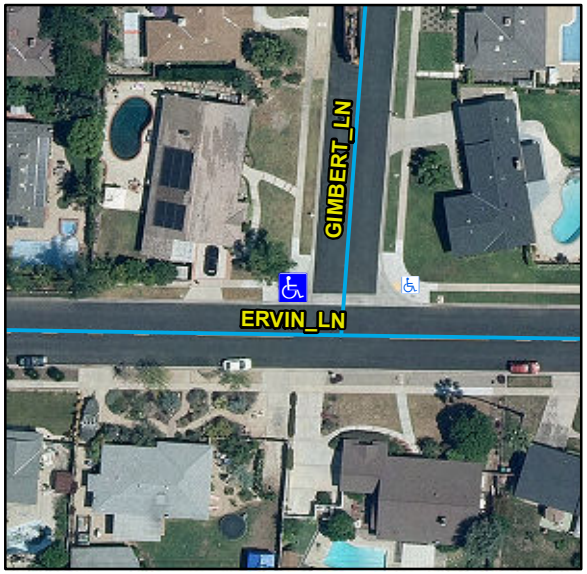
R304.2.2, R304.2.1, R304.2.2-Perp, R304.3.2-Para, R304.5.3, STD 1115

Remove & Replace Curb Ramp With Two New Directional Ramps or Equivalent. Remove & Replace Gutter.

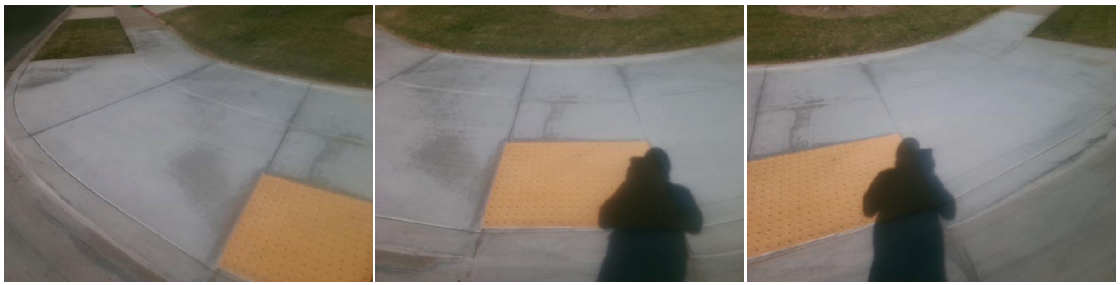
Compliance	Description	Data	Compliance	Description	Data
N/A	Ramp Length (in)	70	N/A	Flare Type LT	
Yes	Ramp Width (in)	48			Sloped
Yes	Ramp Run Slope (%)	7	N/A	Flare Slope LT (%)	5.8
Yes	Ramp Cross Slope (%)	0.6	N/A	Flare Traversable LT	No
N/A	Landing Present	Yes	N/A	Flare Type RT	
N/A	Landing Length (in)	49			Sloped
Yes	Landing Width (in)	48	N/A	Flare Slope RT (%)	8.5
No	Landing Run Slope (%)	2.4	N/A	Flare Traversable RT	No
Yes	Landing Cross Slope (%)	0.7	Yes	DWS Provided	Yes
N/A	Landing Movement Obstructed?	Yes	Yes	DWS Contrast	Yes
	Landing Movement Type	Curb	Yes	DWS Length (in)	36
N/A	Landing Shared	No	Yes	DWS Full Width	Yes
N/A	Clear Space	Yes	Yes	DWS Offset Left (in)	0
N/A	Clear Space To Crosswalk (in)	48	Yes	DWS Offset Right (in)	N/A
N/A	Marked Crosswalk 1	No	N/A	Marked Crosswalk 2	No
	Crossing 1 Direction	S		Crossing 2 Direction	E
	Marked Crosswalk 1 Width (in)	N/A		Marked Crosswalk 2 Width (in)	N/A

N/A	Ramp Inside Crosswalk 1	N/A	Yes	Ramp Inside Crosswalk 2	N/A
	Crossing 1 Slope (%)	4.5		Crossing 2 Slope (%)	2.7
	Crossing 1 Cross Slope (%)	0.2		Crossing 2 Cross Slope (%)	1.5
Yes	Gutter Ponding	No	No	Curb Slope	9.5
Yes	Gutter Lip Height (in)	0		Road Run Slope (%)	1.8
Yes	Gutter Run Slope (%)	0.9		Road Cross Slope (%)	2.3
No	Gutter Cross Slope (%)	2.4			
Yes	Overall Surface Condition: Acceptable		Yes	Perp Joint Present	Yes
	Cross Gutter Present?	Yes		Spandrel Present?	Yes
	Replace Cross Gutter?	No		Replace Spandrel?	No
