DEPARTMENT OF TRANSPORTATION
Structure Maintenance & Investigations

Bridge Number : 55C0038
Facility Carried: SANTIAGO CNYN ROAD
Location : 0.2 MI W/O SILVERADO CYN
City :
Inspection Date : 05/06/2019

Bridge Inspection Report

STRUCTURE NAME: SANTIAGO CREEK

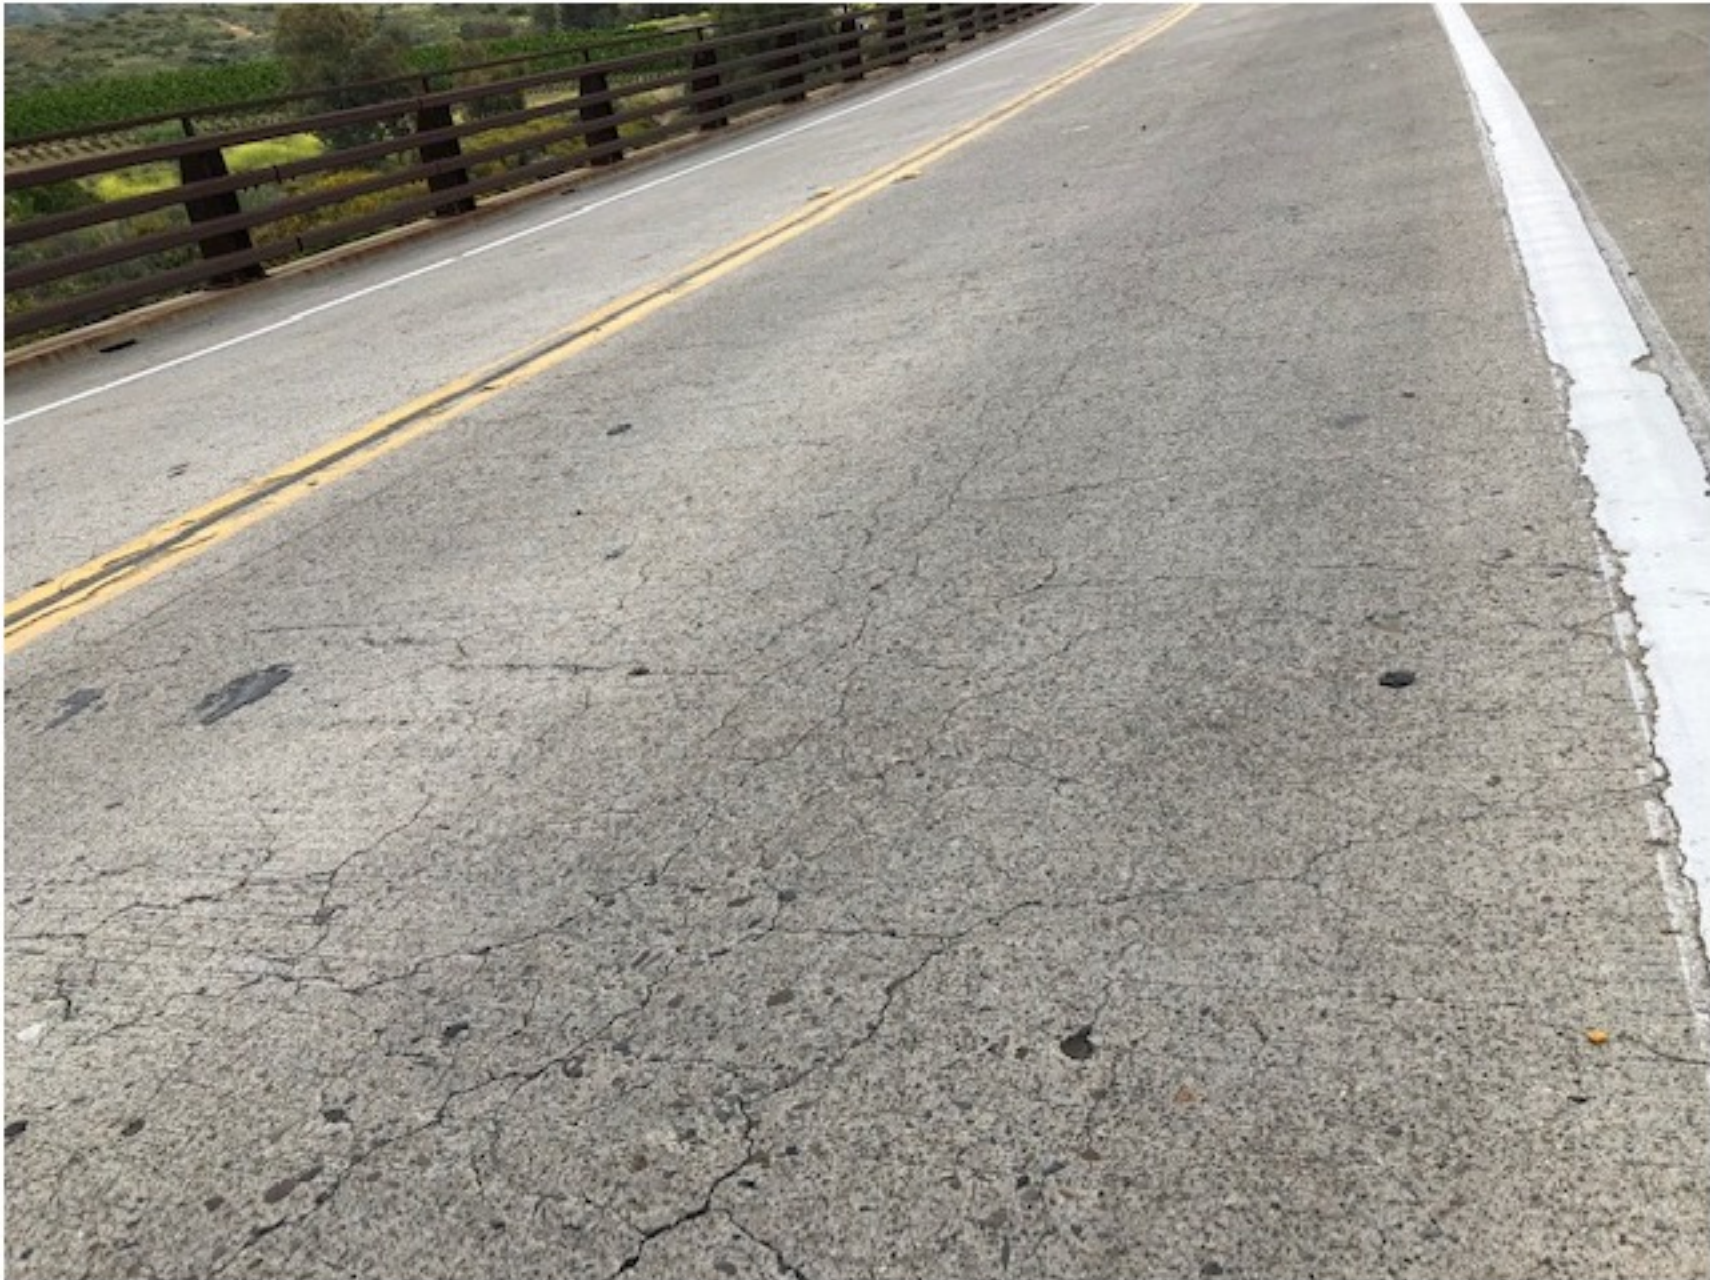
Photo No. 1

Elevation shows superstructure, substructure elements and upstream/downstream.
