Bridge Report Transmittal Sheet

Bridge Number : 55C0606
Facility Carried: OSO PARKWAY
Location : 0.6 MI E/O FELIPE ROAD
City :
Inspection Date : 08/31/2018

Bridge Inspection Report

STRUCTURE NAME: ARROYO TRABUCO

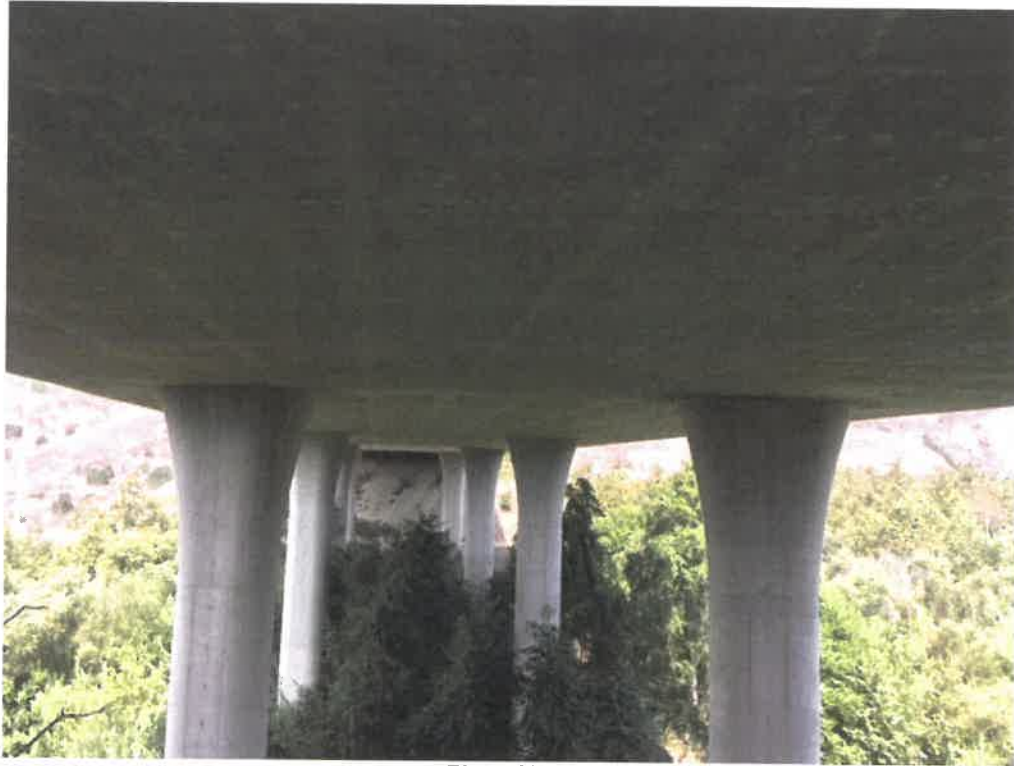
Photo No. 1

Strip seals at hinge (only 01 hinge on this structure).

Replace entire type B seal at the westerly abutment. In addition, clean out all debris inside the strip seals at hinge and easterly abutment joint at 2.5 inches to 3.0 inches gap at 85.0 F degree.
