## **Orange County Bridge Review Summary**

**Bridge Number:** 55C0121

**Bridge Name:** Brea Canyon Channel

**Facility Carried:** Brea Canyon BLVD

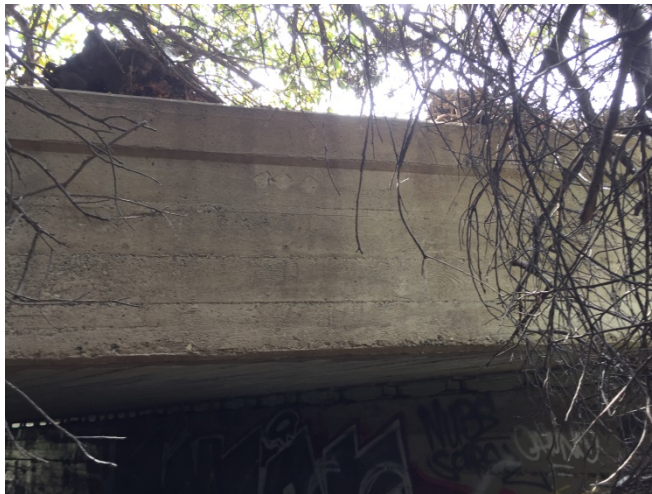
Photo 4: Pier Wall

- There was limited access to the substructure.
- Exposed rebar on pier wall (photo 2).
- Confirmed vegetation overgrowth in channel. Recommend clearing and grubbing the channel.
- Portion of road is being undermined. Recommend removing portion of AC and filling and reconstructing the eroded slope. Investigate if roadside drainage pattern is causing erosion.
- Rutting at power pole. Recommend filling eroded slope. (photo 3)

| Elem No. | Defect /Prot | Defect | Element Description | Env | Total Qty | Units | Qty in each State | Condition | State |
|---|---|---|---|---|---|---|---|---|---|
| There is 10' x 2' x 2" spall in the west side at the north end with exposed rebars and delamination in the east side of the northend of the peirwall #2 | | | | | | | | | |

- Repair spalled pier wall. This should be performed soon to prevent additional corrosion of reinforcement.

- Recommend patching spalled concrete on pier wall.

Repair the spall and delamination at the north side of the pier wall west face of the wall 3 m x 0.6 m x 50 mm spall and at the east face of the wall the delamination area 3 m x 0.5 m.
