## **Orange County Bridge Review Summary**

**Bridge Number:** 55C0122

**Bridge Name:** Brea Canyon Channel

**Facility Carried:** Brea Canyon BLVD

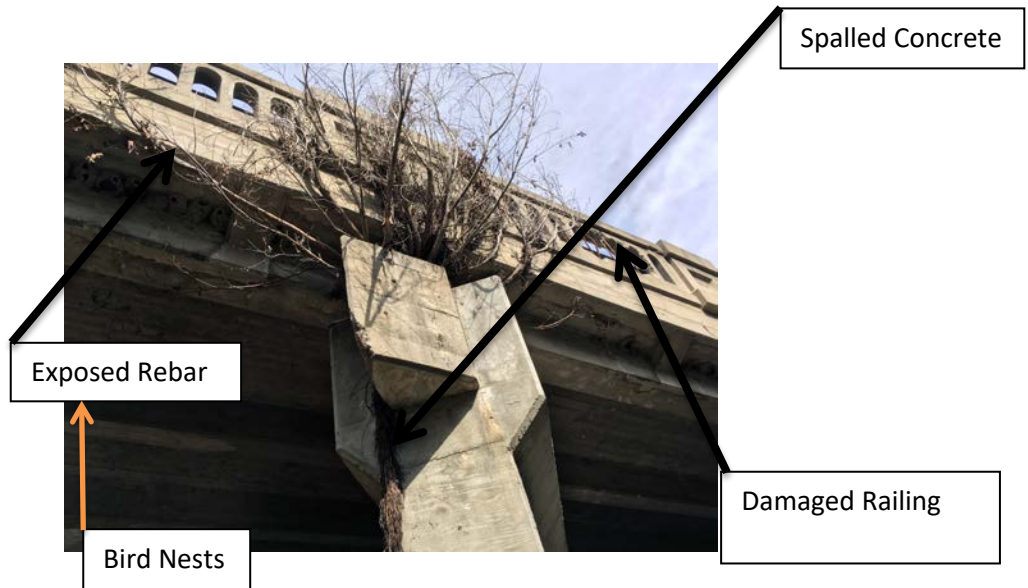
Photo 3: Bridge Soffit

- Confirmed that the concrete railing has been damaged (photo 1).
- Soffit efflorescence visible. This is indicative of water seepage through deck cracks (photo 2).
- Excessive AC on deck, which will reduce load capacity and long-term bridge health. Recommend no additional AC overlay, and County may consider removing some of the AC.
- Exposed rebar on girder soffit (photo 2).
- Vegetation overgrowth in channel and on Pier 2.
- Bird nests visible on bridge overhang (photo 3 and 4). Work may need to take place outside the bird-nesting season.
