Orange County Bridge Review Summary

Bridge Number: 55C0182

Bridge Name: Silverado Canyon Creek

Field Inspection Observations

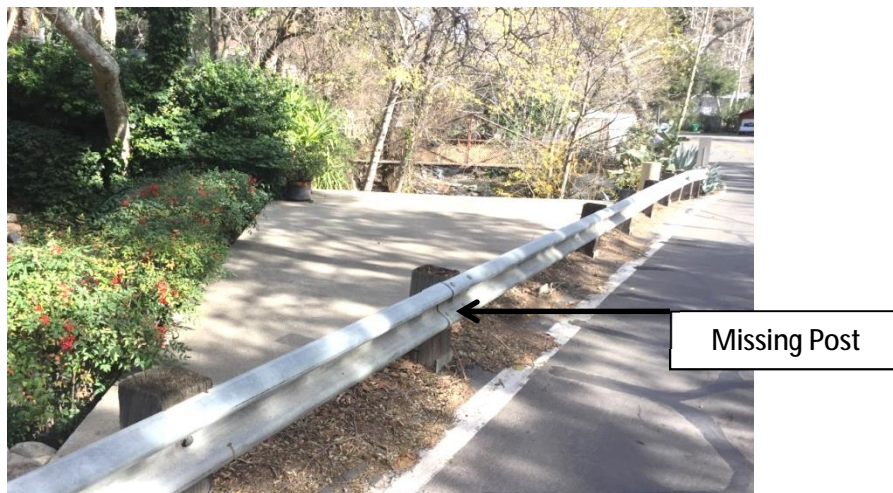
Photo 2:

- Bottom of retaining wall is exposed due to erosion and lower portion of wingwall is broken (photo 4 and 5).
- Minor efflorescence visible on vertical cracks along walls (photo 2) and soffit.
- Rock pocket above wall drain (photo 6). Recommend Patching
- Confirmed missing timber posts. Top of railing post are rotting. Recommend replacing missing and rotting posts. Note this work is not eligible for BPMP reimbursement.

The soffit exhibits two full length longitudinal cracks 1.5 mm wide with light brown efflorescence; and a crack 8 ft long and 1.5 mm wide with white efflorescence.

There are vertical cracks 5 cracks 0.5 mm wide in the east abutment wall. The west abutment exhibits 4 vertical cracks up to 1.5 mm wide; and a void 18" X 15" X 10" behind the abutment at south end at 2 ft above the ground level.

- Replace railing timber posts.
- Efflorescence likely from water penetrating through deck. Not significant problem at this time. Condition must worsen to be eligible for BPMP funding. To repair will require deck AC removal, deck treatment, and grinding approach AC to conform to lower deck elevation.
