Orange County Bridge Review Summary

Bridge Number: 55C0205

Bridge Name: Santa Ana Delhi Channel

Facility Carried: Santa Ana Avenue

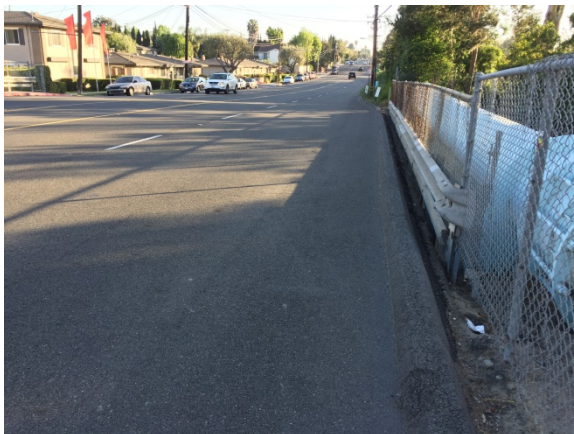
Photo 5: Exposed Sheathing

- Efflorescence and water stains are visible on bridge soffit. The bridge deck has several inches of AC therefore the condition of the bridge deck cannot be assessed.
- Confirmed that there is vegetation growing at abutment 1 (photo 3).
- There appears to be 8-10" of asphalt concrete. Recommend that no additional AC be placed on the bridge deck, and consider removing some of existing AC.
- Concrete spalling on exterior girder (photo 4).
- There is exposed sheathing at abut face (photo 5).
