Orange County Bridge Review Summary

Bridge Number: 55C0550

Bridge Name: Aliso Creek

Facility Carried: Aliso Creek Road

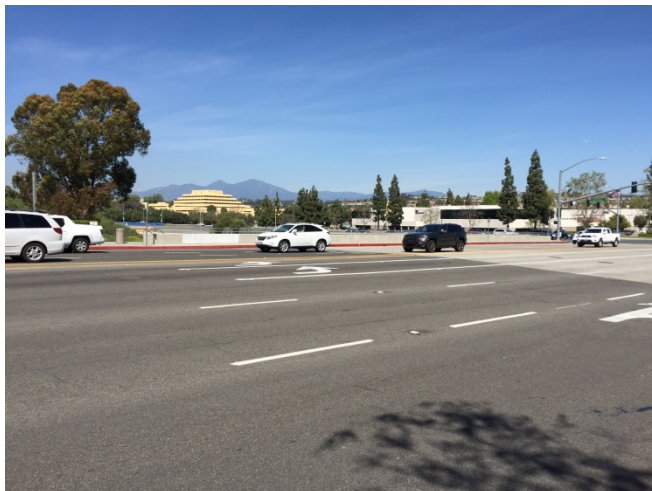
Photo 2:

- Due to traffic, there was limited deck access. Efflorescence visible on bridge soffit (photo 1), this may be a result of a leaking utility. Recommend determining if there are utilities through bridge that may be leaking, since moisture must be present in bridge cells to cause the efflorescence.
- Some down drains are clogged (photo 2). Note this is not eligible for BPMP funds.

- Clean out down drains.
