Orange County Bridge Review Summary

Bridge Number: 55C0561

Bridge Name: Dana Point Harbor

Field Inspection Observations

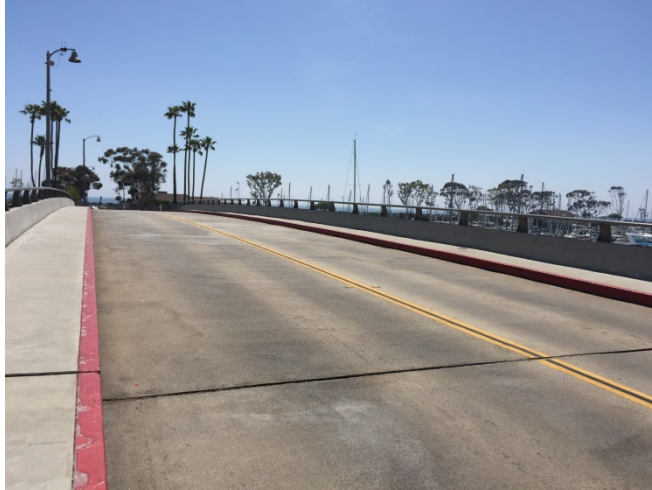
Photo 3:

- Minor spalling on walkway
- There was minimal access to the substructure (photo 1 and 2). Overall this bridge appears to be in good condition.
- Joint seals filled with debris. (photo 3) No immediate action required.
