INSPECTION REPORT

Inspection Date: 3/5/2019

Inspected By: Fortunato Enriquez, PE
Dokken Engineering

Bridge Name: Arroyo Trabuco

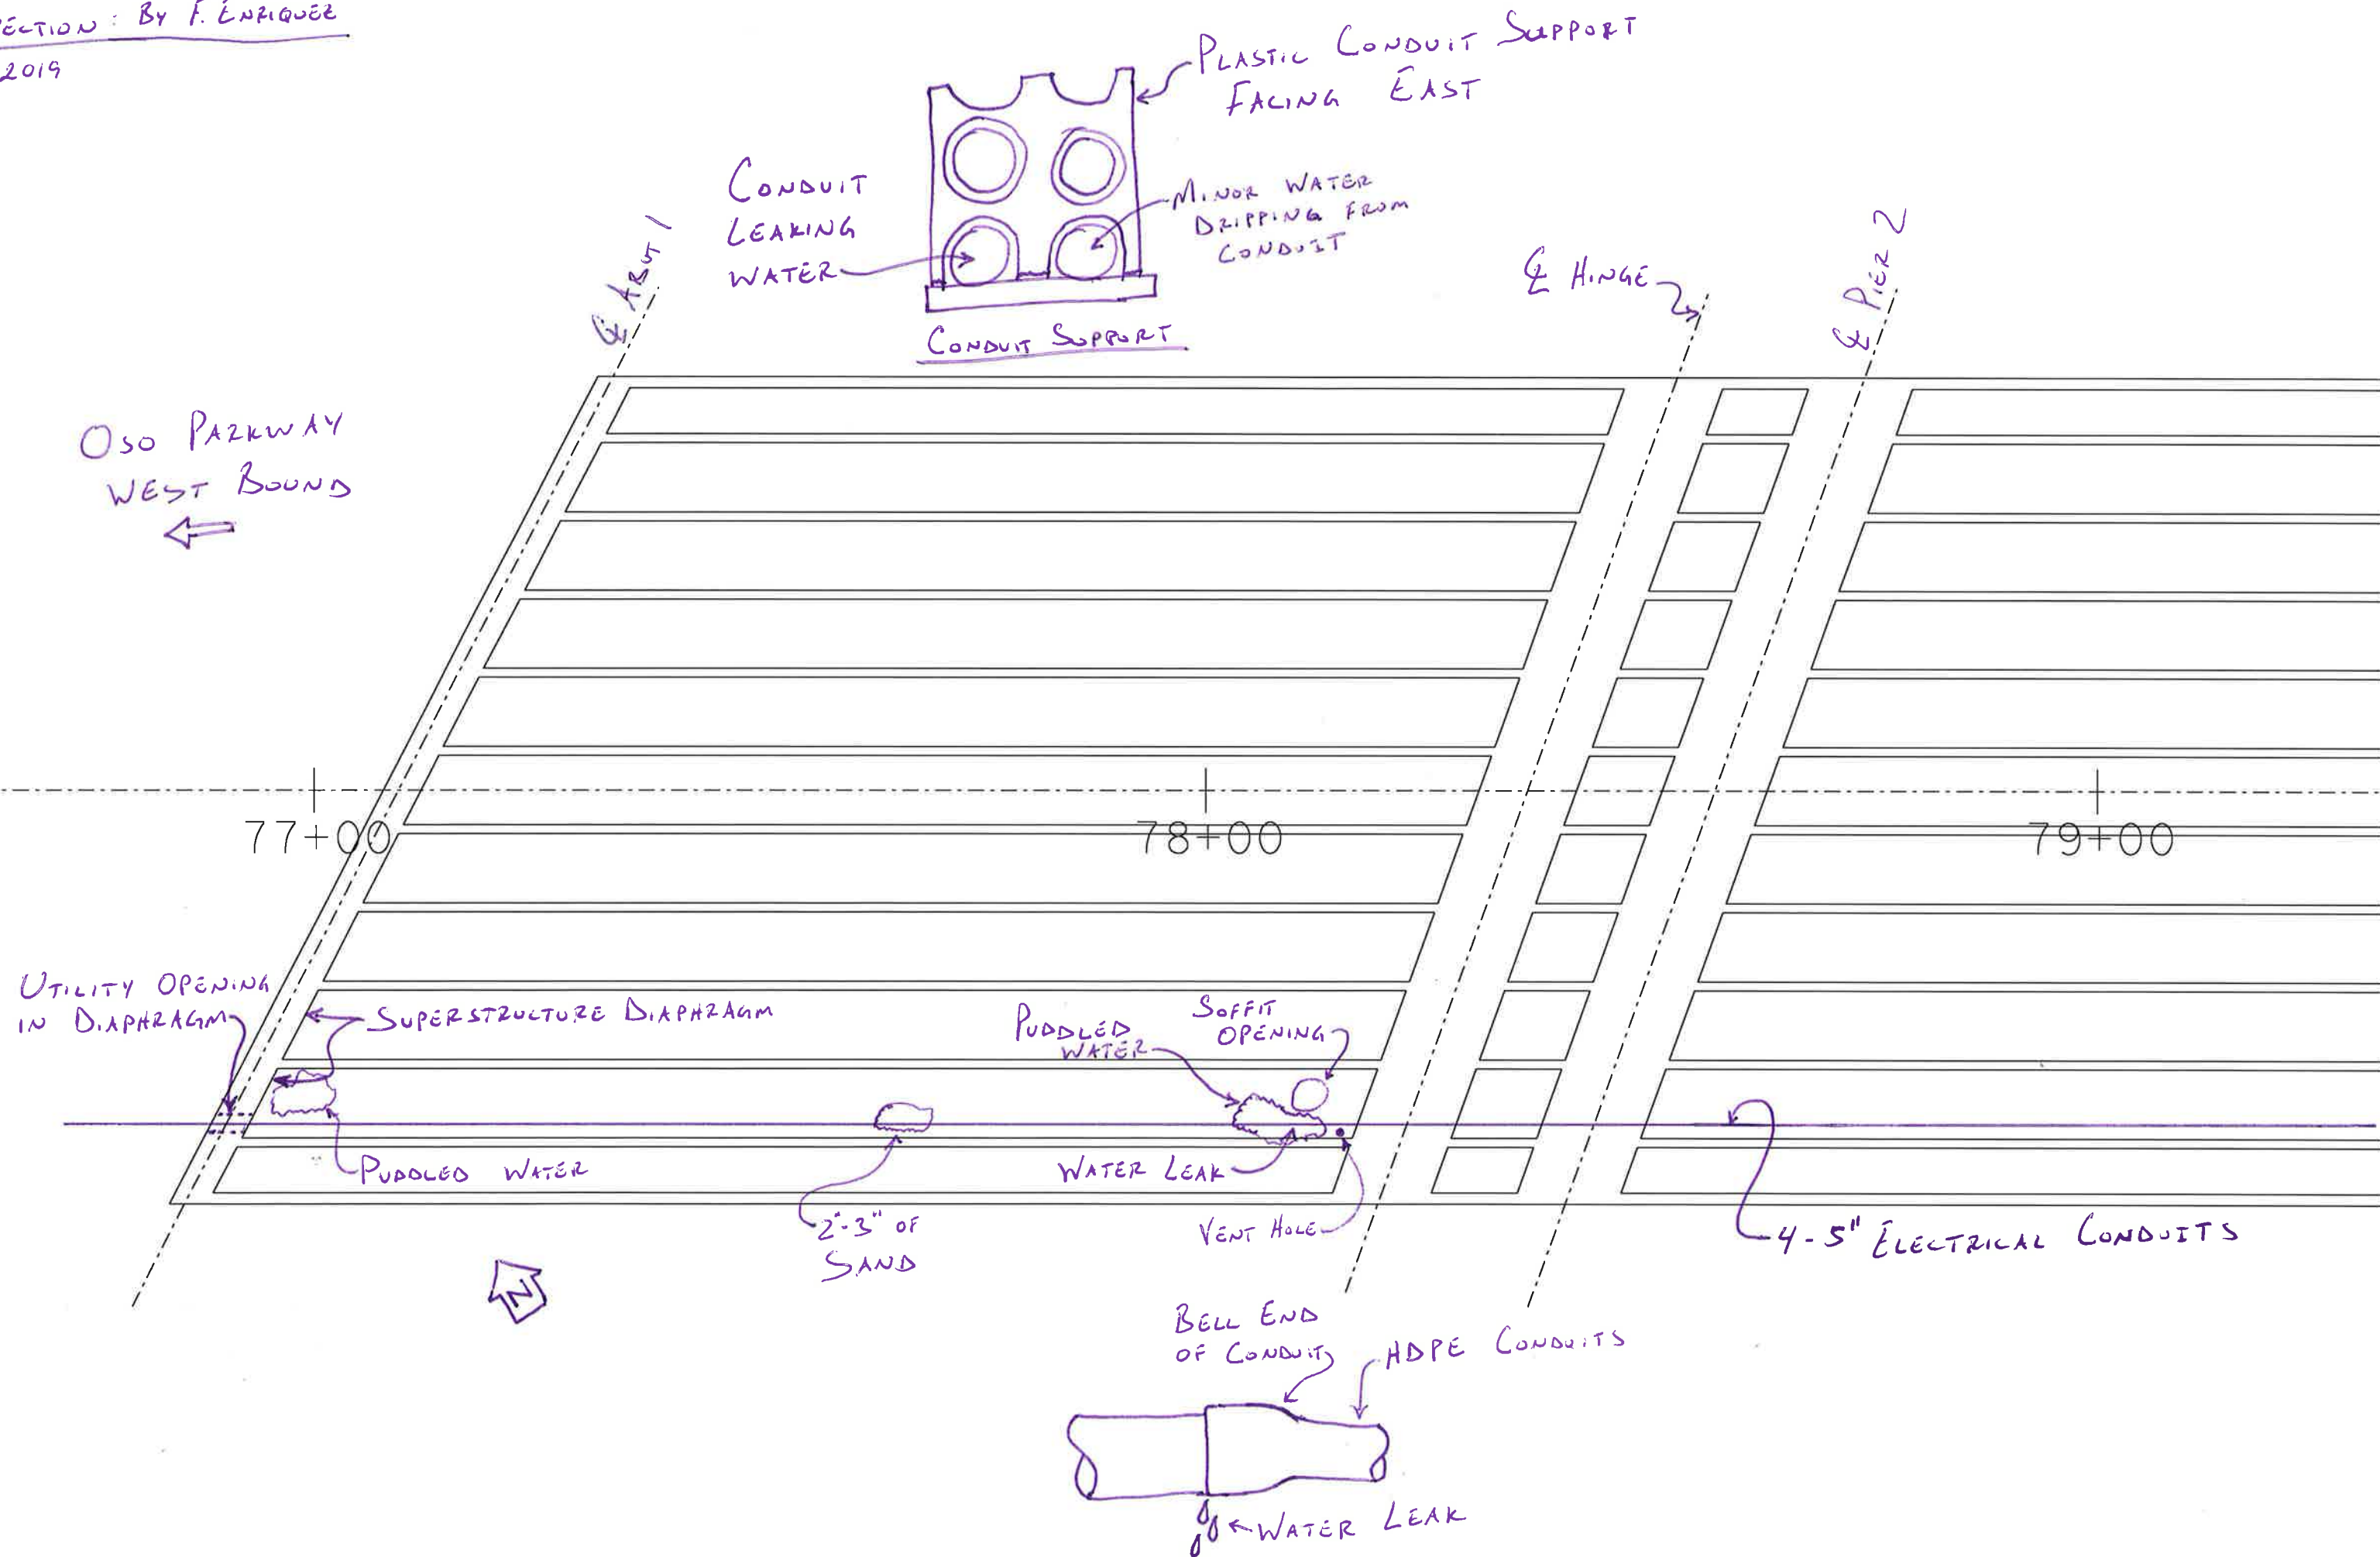
Photo 10: Utility opening through the superstructure diaphragm. The bottom of the utility opening was damp. There was no indication water was leaking from the electrical conduits at this location.
