Orange County Bridge Review Summary

Bridge Number: 55C0631

Bridge Name: Santa Anna River Channel

Facility Carried: Harbor Boulevard

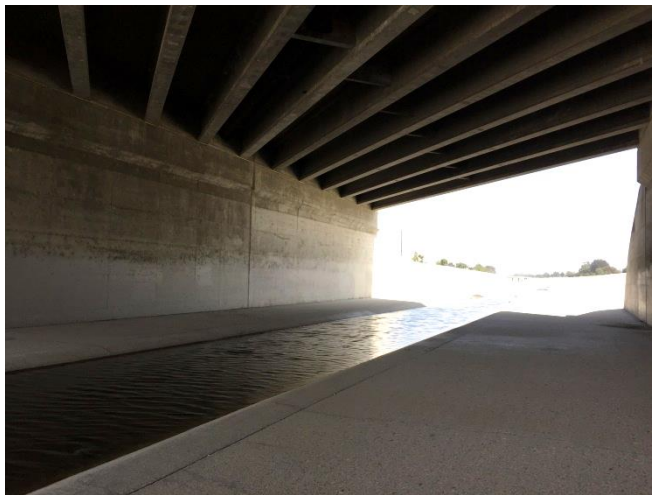
Photo 1: Santa Anna River Channel

- Plugged drain inlets.
- Efflorescence visible on the bridge soffit (photo 1). Per site inspection it appears the bridge deck has been treated. Need to confirm with OCPW.

- N/A – No eligible maintenance activities, unless bridge deck has not been treated. Treating the deck is eligible for BPMP funding since deck is condition state 2.
