Orange County Bridge Review Summary

Bridge Number: 55C0637

Bridge Name: Arroyo Trabuco

Facility Carried: Crown Valley PKWY

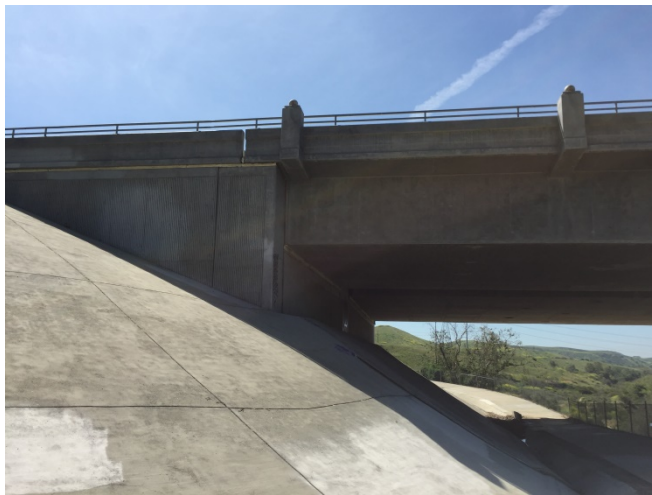
Photo 1:

- There is efflorescence visible on soffit near the soffit opening cover plate which is heavily corroded. Water leaking/dripping in span 1, this appears to be a water line.
- Torn joint seal (photo 1).

- Repair joint seal assembly.
