# Access Compliance Report Public Rights-of-Way (Island Curb Cuts)

Main Street:OSO\_PKWY Cross Street:ANTONIO\_PKWY Location: NW

ADA ID: CCAT220208132212 Curb Cut Type:IslandRefuge3 Initial Pass/Fail: Pass Overall Compliance: No Severity Score: 50

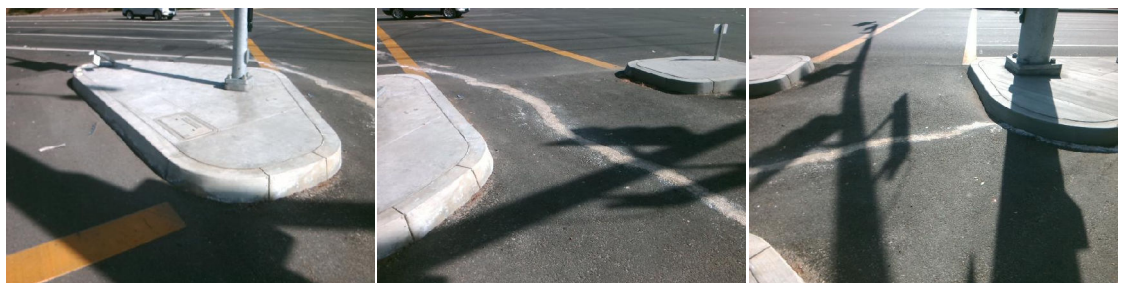
| Compliance | Description | Data | Compliance | Description | Data |
|---|---|---|---|---|---|
| Yes | Refuge 1 Length (In) | 64 | Yes | Guttter 1 Ponding | No |
| Yes | Refuge 1 Width (In) | 90 | Yes | Gutter 1 Lip Ht (In) | 0 |
| Yes | Refuge 1 Slope (%) | 4.1 | No | Gutter 1 Slope (%) | 5.5 |
| Yes | Refuge 1 Cross Slope (%) | 2.51 | Yes | Gutter 1 Cross Slope (%) | 1.8 |

Possible Solutions:  
**Install Detectable Warning System. Restripe Crosswalk. Remove & Replace Gutter.**
