# Access Compliance Report Public Rights-of-Way (Island Curb Cuts)

Main Street: CARBON\_CANYON\_RD Cross Street: VALENCIA\_AVE Location: SE

ADA ID: CCRK220201121941 Curb Cut Type: IslandRefuge3 Initial Pass/Fail: Pass Overall Compliance: No Severity Score: 25

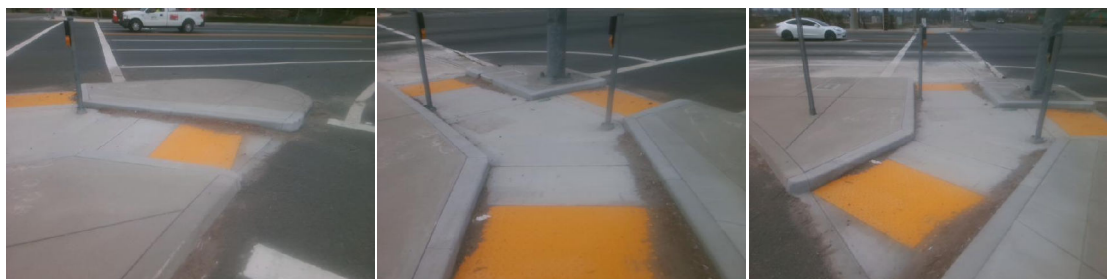
| Compliance | Description | Data | Compliance | Description | Data |
|---|---|---|---|---|---|
| Yes | Obstructions Present? | No | N/A | Utilities Present? | Yes |
| | Obstruction Types | N/A | | Utility Types | |
| | Obstruction Dimensions | N/A | | Push Button | |

**Remove & Replace Detectable Warning System.  
Utility Present.**
