# Access Compliance Report Public Rights-of-Way (Curb Ramps)

Main Street: E\_YORBA\_LINDA\_BLV D Cross Street: HAMER\_LN Location: SE

ADA ID: RPAT210917133630 Ramp Type:Type 1 - Perpendicular Diagonal Initial Pass/Fail: Fail Overall Compliance: No Severity Score: 2

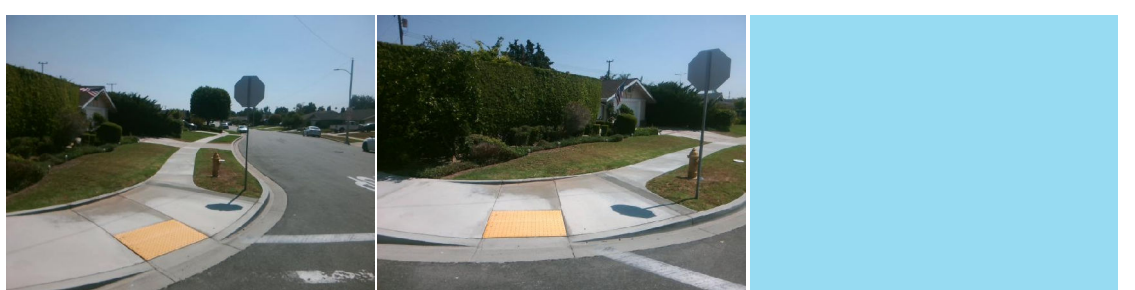
| Compliance | Description | Data | Compliance | Description | Data |
|---|---|---|---|---|---|
| No | Ramp Cross Slope (%) | 2.4 | N/A | Flare Traversable LT | N/A |

Possible Solutions:  
**Remove & Replace Curb Ramp With Two New Directional Ramps or Equivalent.**
