# Access Compliance Report Public Rights-of-Way (Curb Ramps)

| Main Street: N/A | | Cross Street: ESPERANZA_RD | | Location: | NE |
| ADA ID: RPAT210923133953 | Ramp Type:Type 1 - Perpendicular | Initial Pass/Fail: Fail | Overall Compliance: No | Severity Score: | 30 |

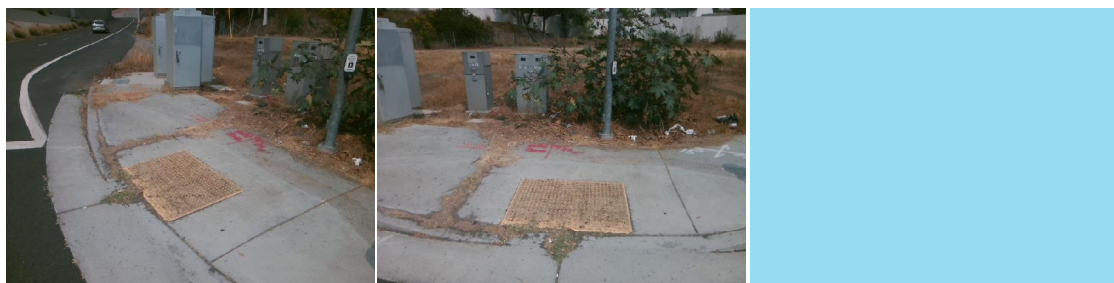
| Compliance | Description | Data | Compliance | Description | Data |
|---|---|---|---|---|---|
| No | Overall Surface Condition: | Poor | Yes | Perp Joint Present | Yes |

Remove & Replace Entire Ramp.
