# Access Compliance Report Public Rights-of-Way (Curb Ramps)

| Main Street: MAGNOLIA_AVE | | Cross Street: BIXBY_AVE | | Location: | NE |
| ADA ID: RPAT210924125725 | Ramp Type: Type 6 - Directional 1 | Initial Pass/Fail: Fail | Overall Compliance: No | Severity Score: | 30 |

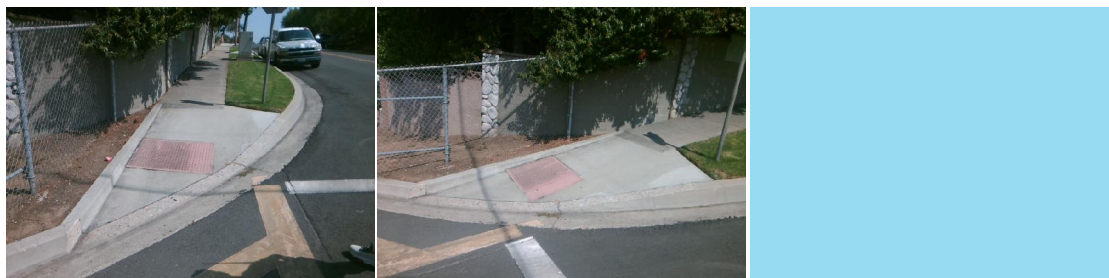
| Compliance | Description | Data | Compliance | Description | Data |
|---|---|---|---|---|---|
| No | Ramp Run Slope (%) | 26.3 | N/A | Flare Slope LT (%) | N/A |

Remove & Replace Entire Ramp.
