# Access Compliance Report Public Rights-of-Way (Curb Ramps)

| Main Street: N_RANCHO_SANTIAGO_BLVD | | Cross Street: E_SYCAMORE_AVE | | Location: | NE |
| ADA ID: RPAT210928085400 | Ramp Type:Type 1 - Perpendicular Diagonal Initial Pass/Fail: Fail | | Overall Compliance: No | Severity Score: | 35 |

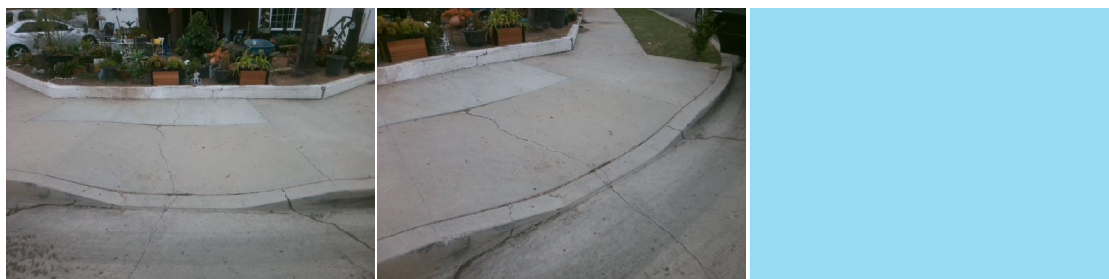
| Compliance | Description | Data | Compliance | Description | Data |
|---|---|---|---|---|---|
| No | Ramp Width (in) | 45 | | | N/A |
| No | Ramp Run Slope (%) | 10.2 | N/A | Flare Slope LT (%) | N/A |
| No | Overall Surface Condition: | Poor | No | Perp Joint Present | No |

**Remove & Replace Curb Ramp With Two New Directional Ramps or Equivalent.**
