Access Compliance Report Public Rights-of-Way (Curb Ramps)

Main Street: RANCHO_SANTIAGO_BLV **Cross Street:** VINE_ST **Location:** SW

ADA ID: RPAT210928092246 **Ramp Type:** Type 4 - Parallel **Initial Pass/Fail:** Fail **Overall Compliance:** No **Severity Score:** 16

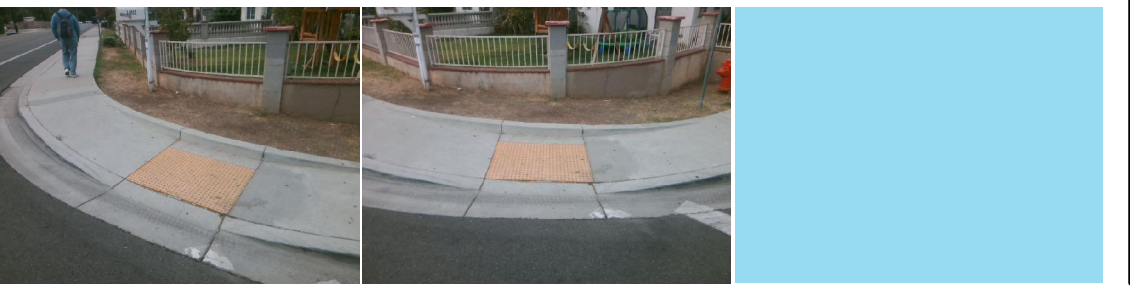
Compliance	Description	Data	Compliance	Description	Data
N/A	Ramp Length LT (in)	97	N/A	Ramp Length RT (in)	107
Yes	Ramp Width LT (in)	48	Yes	Ramp Width RT (in)	48
No	Ramp Run Slope LT (%)	11.1	Yes	Ramp Run Slope RT (%)	1.3
No	Ramp Cross Slope LT (%)	2.3	Yes	Ramp Cross Slope RT (%)	0.1
N/A	Landing Present	N/A	N/A	DWS Provided	N/A
N/A	Landing Length (in)	N/A	N/A	DWS Contrast	N/A
N/A	Landing Width (in)	N/A	N/A	DWS Length (in)	N/A
N/A	Landing Run Slope (%)	N/A	N/A	DWS Full Width	N/A
N/A	Landing Cross Slope (%)	N/A		DWS Offset Type	N/A
N/A	Landing Movement Obstructed?	N/A	N/A	DWS Offset Left (in)	N/A
	Landing Movement Type	N/A	N/A	DWS Offset Right (in)	N/A
N/A	Landing Shared	N/A			
N/A	Clear Space	Yes			
N/A	Clear Space To Crosswalk (in)	N/A			
N/A	Marked Crosswalk 1	No	N/A	Marked Crosswalk 2	No
	Crossing 1 Direction	E		Crossing 2 Direction	N
N/A	Marked Crosswalk 1 Width (in)	N/A	N/A	Marked Crosswalk 2 Width (in)	N/A

N/A	Ramp Inside Crosswalk 1	N/A	N/A	Ramp Inside Crosswalk 2	N/A
	Crossing 1 Slope (%)	8.3		Crossing 2 Slope (%)	2.9
	Crossing 1 Cross Slope (%)	1.2		Crossing 2 Cross Slope (%)	7.3
N/A	Gutter Ponding	N/A	N/A	Curb Slope	6.8
Yes	Gutter Lip Height (in)	0		Road Run Slope (%)	4.8
N/A	Gutter Run Slope (%)	N/A		Road Cross Slope (%)	6.1
N/A	Gutter Cross Slope (%)	N/A	Yes	Perpendicular Joint Present	Yes
Yes	Overall Surface Condition	Acceptable			
	Cross Gutter Present?	No		Spandrel Present?	No
	Replace Cross Gutter?	N/A		Replace Spandrel?	N/A

Possible Solutions:
Remove & Replace Curb Ramp With Two New Directional Ramps or Equivalent.
