# Access Compliance Report Public Rights-of-Way (Curb Ramps)

| Main Street: LANESBORO_RD | | Cross Street: STERLING_GLEN | | Location: | SW |
| ADA ID: RPAT211101134821 | Ramp Type: Type 4 - Parallel | Initial Pass/Fail: Fail | Overall Compliance: No | Severity Score: | 15 |

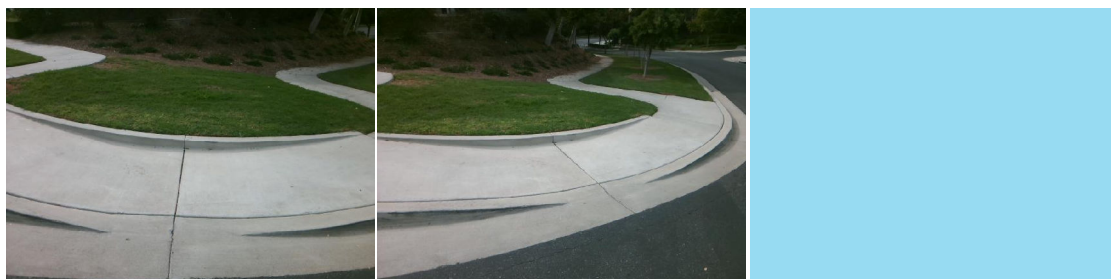
| Compliance | Description | Data | Compliance | Description | Data |
|---|---|---|---|---|---|
| N/A | Ramp Length LT (in) | 115 | N/A | Ramp Length RT (in) | 95 |
| Yes | Ramp Width LT (in) | 53 | Yes | Ramp Width RT (in) | 53 |
| No | Ramp Run Slope LT (%) | 12 | Yes | Ramp Run Slope RT (%) | 4.5 |

**Remove & Replace Curb Ramp With Two New Directional Ramps or Equivalent.**
