# Access Compliance Report Public Rights-of-Way (Curb Ramps)

| Main Street: HYDRANGEA_ST | | Cross Street: S_SELLAS_RD | | Location: | SW |
| ADA ID: RPAT211102131935 | Ramp Type:Type 1 - Perpendicular Diagonal Initial Pass/Fail: Fail | | Overall Compliance: No | Severity Score: | 16 |

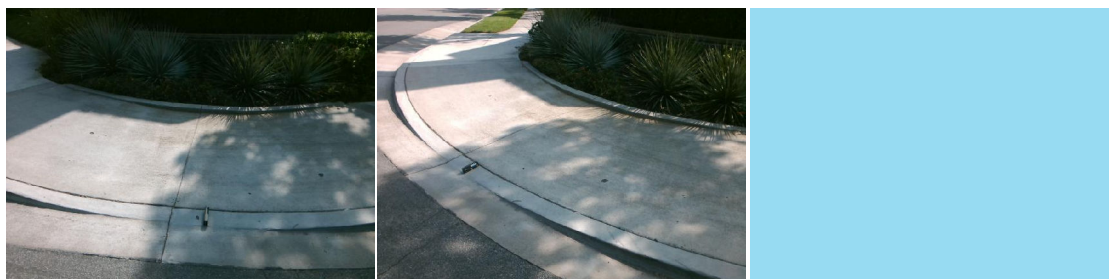
| Compliance | Description | Data | Compliance | Description | Data |
| N/A | Ramp Length (in) | 54 | N/A | Flare Type LT | |
| Yes | Ramp Width (in) | 48 | | | N/A |
| No | Ramp Run Slope (%) | 9.2 | N/A | Flare Slope LT (%) | N/A |

**Remove & Replace Curb Ramp With Two New Directional Ramps or Equivalent.**
