# Access Compliance Report Public Rights-of-Way (Curb Ramps)

| Parcel ID Number | 086-552-06 | Street 1 Name | CHESNEY_DR |

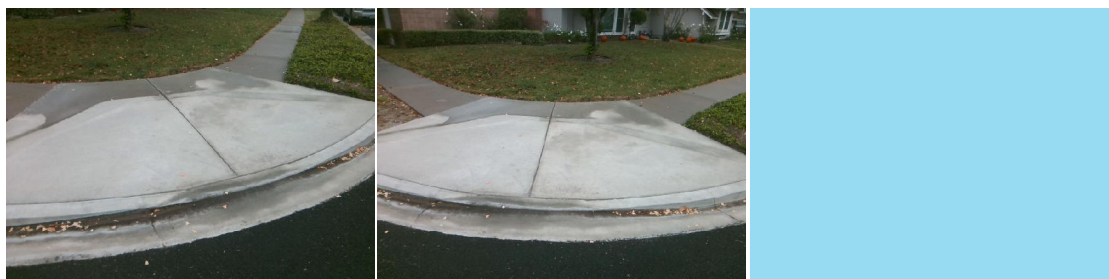
| Compliance | Description | Data | Compliance | Description | Data |
|---|---|---|---|---|---|
| Yes | Obstructions Present? | No | N/A | Utilities Present? | No |

| Compliance | Description | Data | Compliance | Description | Data |
|---|---|---|---|---|---|
| No | Ramp Run Slope (%) | 8.8 | N/A | Flare Slope LT (%) | N/A |

**Remove & Replace Curb Ramp With Two New Directional Ramps or Equivalent.**
