# Access Compliance Report Public Rights-of-Way (Curb Ramps)

| Main Street: FRONTERA_ST | | Cross Street: N_GLASSELL_ST | | Location: | NE |
| ADA ID: RPAT220127092606 | Ramp Type:Type 1 - Perpendicular | Initial Pass/Fail: Fail | Overall Compliance: No | Severity Score: | 20 |

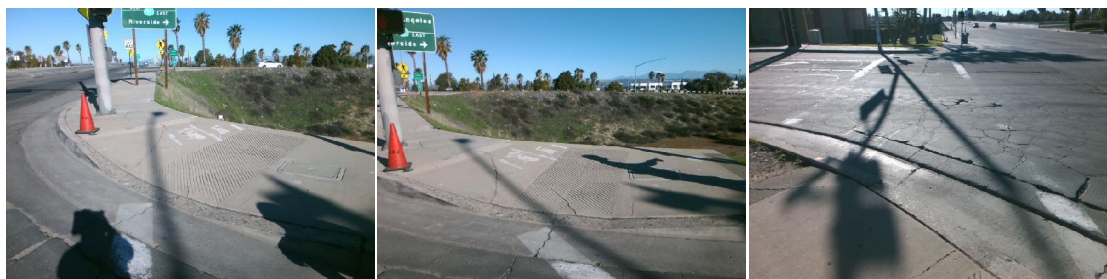
| Compliance | Description | Data | Compliance | Description | Data |
|---|---|---|---|---|---|
| No | Overall Surface Condition: | Poor | No | Perp Joint Present | No |

**Remove & Replace Entire Ramp. Restripe Crosswalk.**
