# Access Compliance Report Public Rights-of-Way (Curb Ramps)

Main Street: LINCOLN\_AVE Cross Street: ORANGE\_OLIVE\_RD Location: SE

ADA ID: RPAT220127102614 Ramp Type: Type 1 - Perpendicular Diagonal Initial Pass/Fail: Fail Overall Compliance: No Severity Score: 45

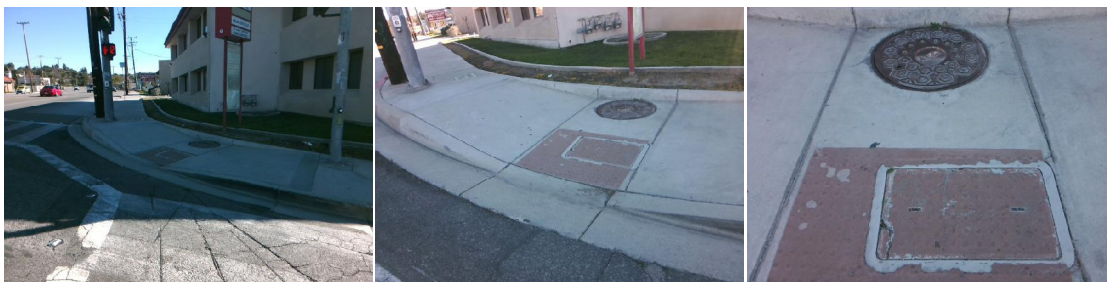
| Compliance | Description | Data | Compliance | Description | Data |
|---|---|---|---|---|---|
| No | Overall Surface Condition: | Poor | Yes | Perp Joint Present | Yes |

Remove & Replace Curb Ramp With Two New Directional Ramps or Equivalent.
