# Access Compliance Report Public Rights-of-Way (Curb Ramps)

| Main Street: SANTO_TOMAS_ST | | Cross Street: SANTA_ANA_AVE | | Location: | N |
| ADA ID: RPAT220128165320 | Ramp Type:Type 1 - Perpendicular | Initial Pass/Fail: Fail | Overall Compliance: No | Severity Score: | 16 |

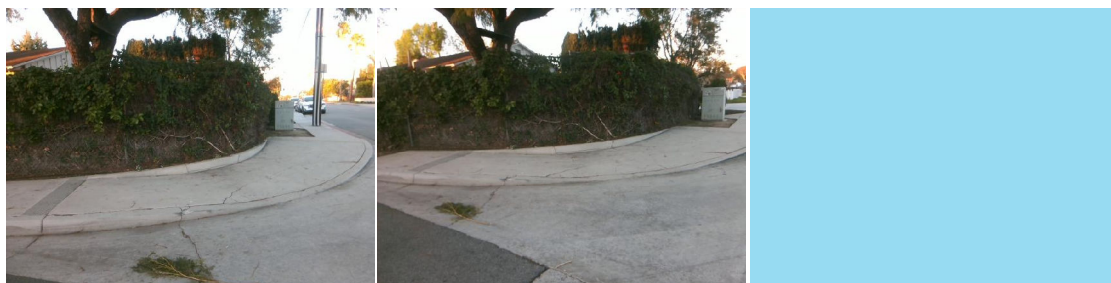
| Compliance | Description | Data | Compliance | Description | Data |
|---|---|---|---|---|---|
| No | Ramp Cross Slope (%) | 2.3 | N/A | Flare Traversable LT | N/A |
| No | Overall Surface Condition: | Poor | No | Perp Joint Present | No |

Remove & Replace Entire Ramp.
