# Access Compliance Report Public Rights-of-Way (Curb Ramps)

| Main Street: HEDLUND_DR | | Cross Street: HARLE_AVE | | Location: | SE |
| ADA ID: RPAT220203142337 | Ramp Type: Type 4 - Parallel | Initial Pass/Fail: Fail | Overall Compliance: No | Severity Score: | 4 |

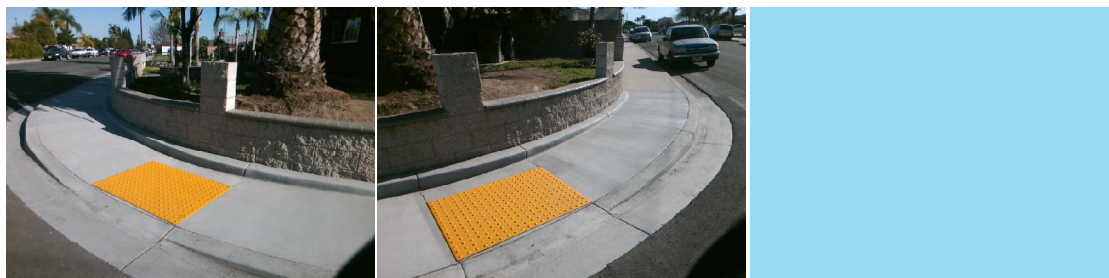
| Compliance | Description | Data | Compliance | Description | Data |
|---|---|---|---|---|---|
| N/A | Ramp Length LT (in) | 96 | N/A | Ramp Length RT (in) | 86 |
| No | Ramp Width LT (in) | 47 | No | Ramp Width RT (in) | 47 |
| Yes | Ramp Run Slope LT (%) | 7.2 | Yes | Ramp Run Slope RT (%) | 5.2 |

**Remove & Replace Curb Ramp With Two New Directional Ramps or Equivalent.**

**R304.5.1, STD 1115**
