# Access Compliance Report Public Rights-of-Way (Curb Ramps)

Main Street: N/A Cross Street: ANTONIO\_PKWY Location: N

ADA ID: RPAT220208121239 Ramp Type: Type 1 - Perpendicular Diagonal Initial Pass/Fail: Fail Overall Compliance: No Severity Score: 32

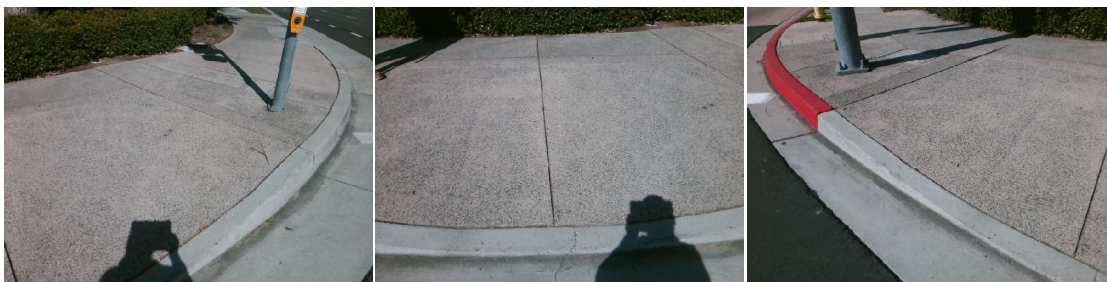
| Compliance | Description | Data | Compliance | Description | Data |
|---|---|---|---|---|---|
| No | Overall Surface Condition: | Poor | No | Perp Joint Present | No |

Remove & Replace Curb Ramp With Two New Directional Ramps or Equivalent.
