# Access Compliance Report Public Rights-of-Way (Curb Ramps)

| Main Street: N/A | | Cross Street: YORBA_LINDA_BLVD | | Location: | SE |
| ADA ID: RPAT220221113738 | Ramp Type:Type 1 - Perpendicular | Initial Pass/Fail: Fail | Overall Compliance: No | Severity Score: | 15 |

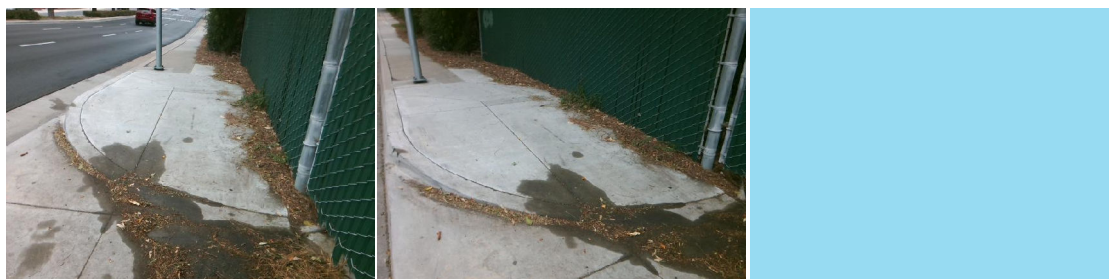
| Compliance | Description | Data | Compliance | Description | Data |
|---|---|---|---|---|---|
| Yes | Overall Surface Condition: Acceptable | | Yes | Perp Joint Present | Yes |

Remove & Replace Entire Ramp.
