# Access Compliance Report Public Rights-of-Way (Curb Ramps)

| Main Street: HAZARD_AVE | | Cross Street: NEWLAND_ST | | Location: | SE |
| ADA ID: RPAT220221145723 | Ramp Type: Type 4 - Parallel | Initial Pass/Fail: Fail | Overall Compliance: No | Severity Score: | 30 |

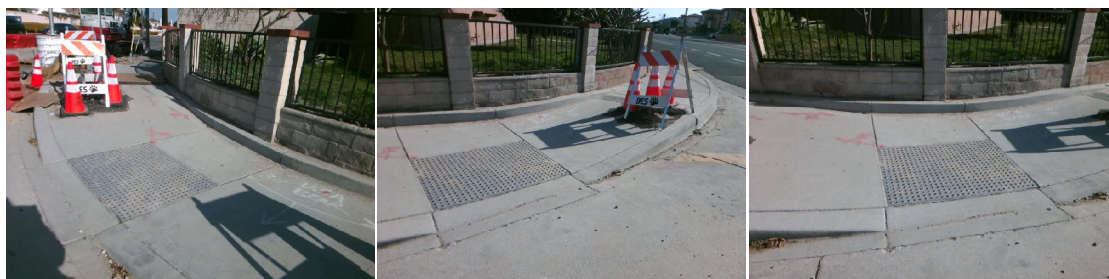
| Compliance | Description | Data | Compliance | Description | Data |
|---|---|---|---|---|---|
| No | Overall Surface Condition | Poor | | | |

**Remove & Replace Curb Ramp With Two New Directional Ramps or Equivalent.**
