# Access Compliance Report Public Rights-of-Way (Curb Ramps)

Main Street: PERDIDO\_ST Cross Street: BIENVILLE\_AVE Location: NE

ADA ID: RPRK210924131615 Ramp Type: Type 1 - Perpendicular Diagonal Initial Pass/Fail: Fail Overall Compliance: No Severity Score: 45

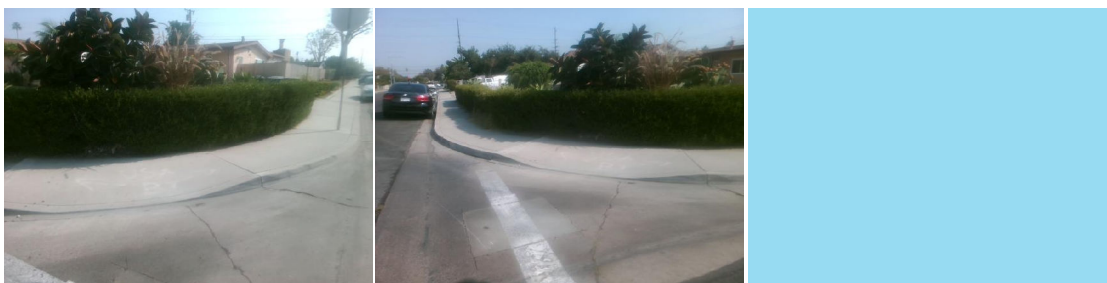
| Compliance | Description | Data | Compliance | Description | Data |
|---|---|---|---|---|---|
| Yes | Overall Surface Condition: Acceptable | | Yes | Perp Joint Present | Yes |
| | Cross Gutter Present? | Yes | | Spandrel Present? | Yes |
| | Replace Cross Gutter? | No | | Replace Spandrel? | No |
