# Access Compliance Report

## Public Rights-of-Way

### (Curb Ramps)

Main Street: DALE\_ST Cross Street: CHAPMAN\_AVE Location: NW

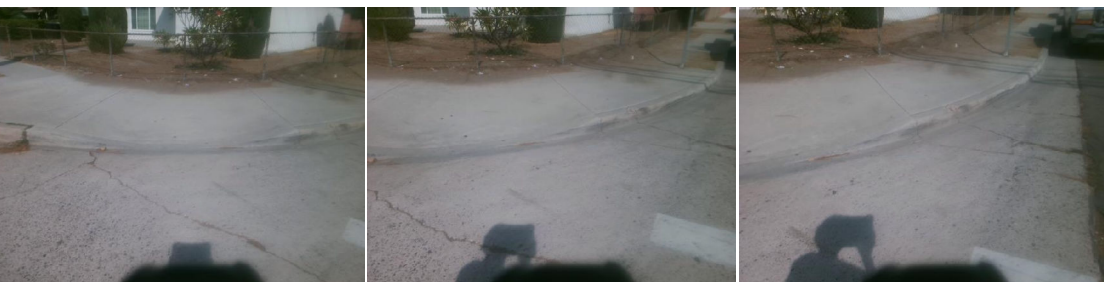
ADA ID: RPRK210928180405 Ramp Type: Type 1 - Perpendicular Diagonal Initial Pass/Fail: Fail Overall Compliance: No Severity Score: 2

**Remove & Replace Curb Ramp With Two New Directional Ramps or Equivalent.**
