Access Compliance Report Public Rights-of-Way (Curb Ramps)

Main Street: MCFADDEN_AVE **Cross Street:** WILSON_ST **Location:** NW

ADA ID: RPRK210930113620 **Ramp Type:** Type 1 - Perpendicular Diagonal Initial Pass/Fail: Fail **Overall Compliance:** No **Severity Score:** 15

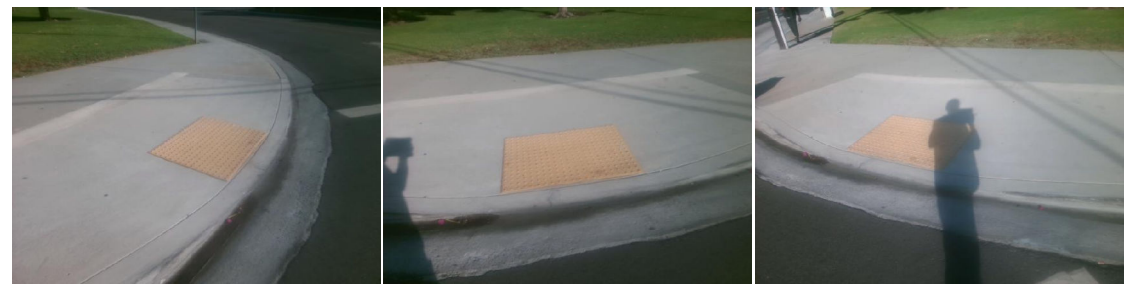
Compliance	Description	Data	Compliance	Description	Data
Yes	Obstructions Present?	No	N/A	Utilities Present?	No
	Obstruction Types	N/A		Utility Types	
	Obstruction Dimensions	N/A			N/A
