# Access Compliance Report Public Rights-of-Way (Curb Ramps)

Main Street: VAN\_BUREN\_ST Cross Street: MADISON\_AVE Location: NE

ADA ID: RPRK211001193742 Ramp Type: Type 1 - Perpendicular Diagonal Initial Pass/Fail: Fail Overall Compliance: No Severity Score: 34

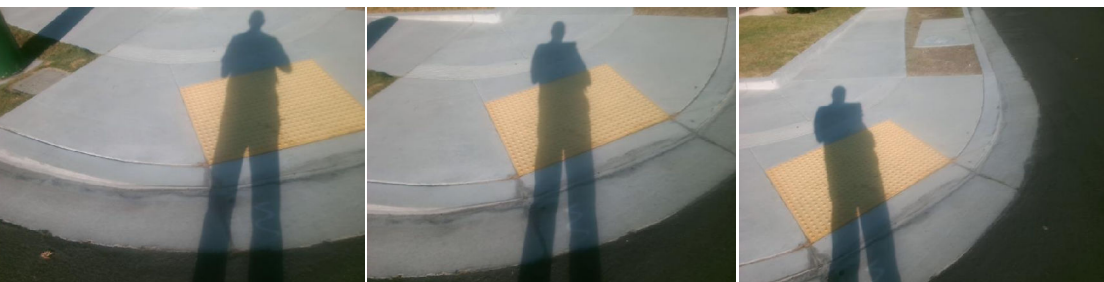
| Compliance | Description | Data | Compliance | Description | Data |
|---|---|---|---|---|---|
| No | Ramp Width (in) | 36 | | | N/A |

Remove & Replace Curb Ramp With Two New Directional Ramps or Equivalent.
