# Access Compliance Report Public Rights-of-Way (Curb Ramps)

| Main Street: ARBOLADA_WAY | | Cross Street: PROSPECT_AVE | | Location: | SE |
| ADA ID: RPRK211011123906 | Ramp Type:Type 1 - Perpendicular Diagonal | | Initial Pass/Fail: Fail | Overall Compliance: No | Severity Score: 30 |

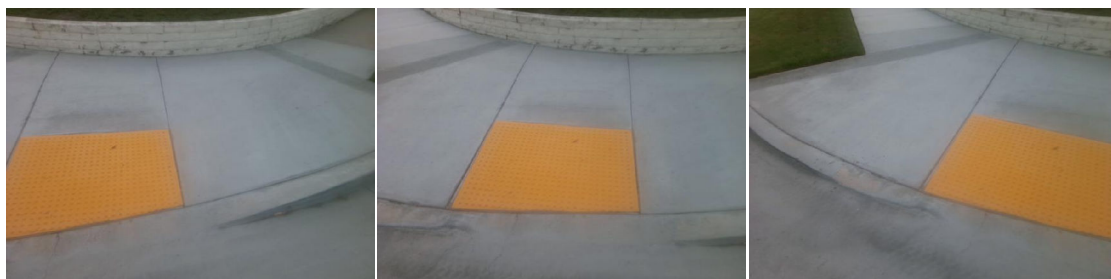
| Compliance | Description | Data | Compliance | Description | Data |
|---|---|---|---|---|---|
| No | Ramp Run Slope (%) | 15.8 | N/A | Flare Slope LT (%) | N/A |

**Remove & Replace Curb Ramp With Two New Directional Ramps or Equivalent.**
