# Access Compliance Report Public Rights-of-Way (Curb Ramps)

Main Street: MELVIN\_WY Cross Street: RED\_HILL\_AVE Location: E

ADA ID: RPRK211014142637 Ramp Type: Type 1 - Perpendicular Initial Pass/Fail: Fail Overall Compliance: No Severity Score: 16

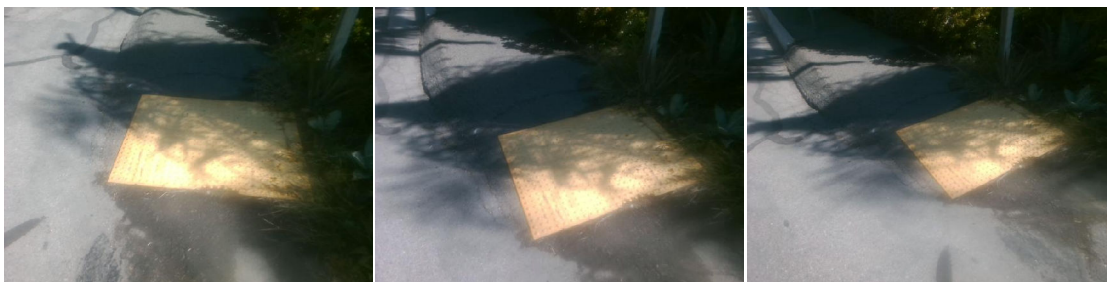
| Compliance | Description | Data | Compliance | Description | Data |
|---|---|---|---|---|---|
| No | Overall Surface Condition: | Poor | No | Perp Joint Present | No |

Remove & Replace Entire Ramp.
