# Access Compliance Report Public Rights-of-Way (Curb Ramps)

| Main Street: MAYBECK_LN | | Cross Street: MAYBECK_LN | | Location: | E |
| ADA ID: RPRK211025114144 | Ramp Type: Type 1 - Perpendicular | Initial Pass/Fail: Fail | Overall Compliance: No | Severity Score: | 2 |

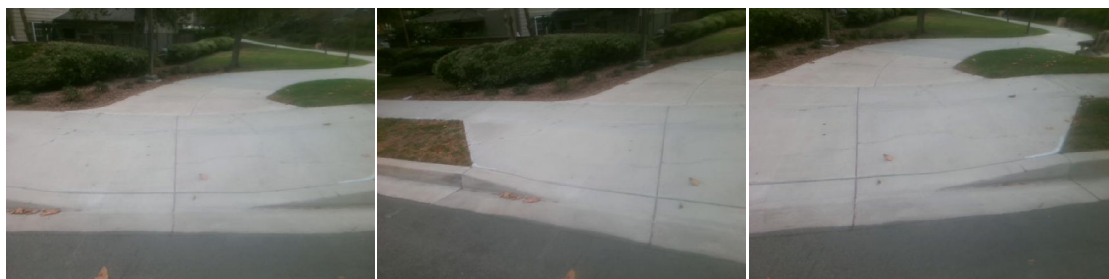
| Compliance | Description | Data | Compliance | Description | Data |
|---|---|---|---|---|---|
| No | Ramp Cross Slope (%) | 4.4 | N/A | Flare Traversable LT | N/A |

Remove & Replace Entire Ramp.
