# Access Compliance Report

## Public Rights-of-Way

### (Curb Ramps)

Main Street: LODEN\_PASS Cross Street: TAFFETA\_LN Location: W

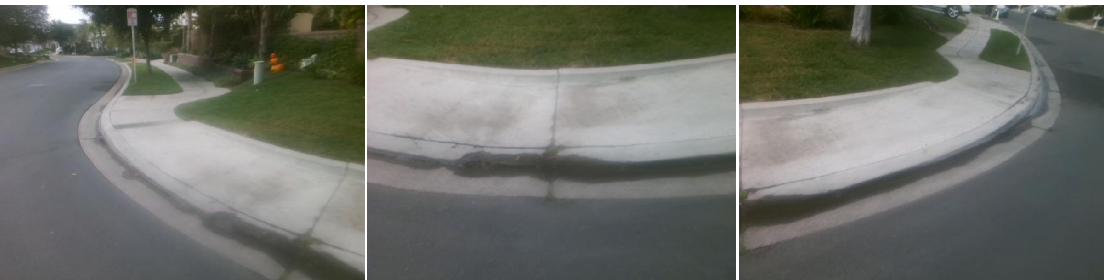
ADA ID: RPRK211104131035 Ramp Type: Type 4 - Parallel Initial Pass/Fail: Fail Overall Compliance: No Severity Score: 2

**Remove & Replace Curb Ramp With Two New Directional Ramps or Equivalent.**
