# Access Compliance Report Public Rights-of-Way (Curb Ramps)

| Main Street: SUGARCANE_LN | | Cross Street: LODEN_PASS | | Location: | N |
| ADA ID: RPRK211104131243 | Ramp Type: Type 4 - Parallel | Initial Pass/Fail: Fail | Overall Compliance: No | Severity Score: | 15 |

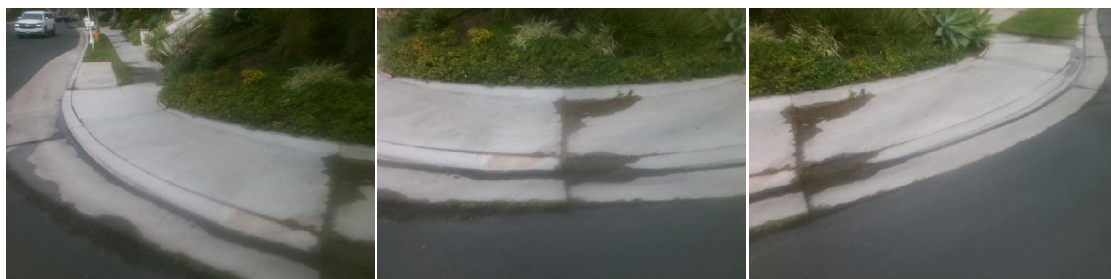
## Obstruction and Utility Measurement/Component Compliance

| Compliance | Description | Data | Compliance | Description | Data |
|---|---|---|---|---|---|
| Yes | Obstructions Present? | No | N/A | Utilities Present? | No |
